**Alcoa Power Generating Inc.
Yadkin Division**

Yadkin Project Relicensing (FERC No. 2197)

Project-Wide Aesthetic Study

Draft Report

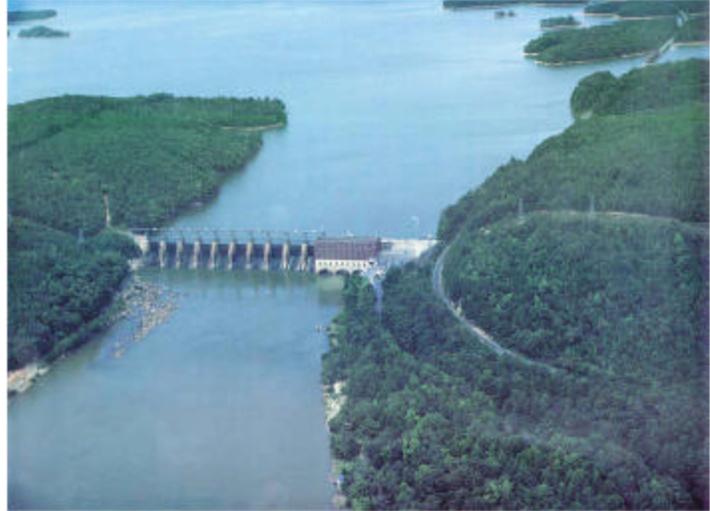
High Rock Dam is a concrete structure approximately 936 feet long with a maximum height of approximately 101 feet (base of dam to walkway). The dam is comprised of two short non-overflow sections, a gated controlled spillway section, and an integral intake/powerhouse section. The non-overflow sections are located at the east end of the powerhouse and at the west end of the gate-controlled spillway. The gate-controlled spillway section is approximately 550 feet long.

The intake structure includes trashracks and motor operated headgates. The powerhouse is a red-brick structure approximately 178 feet long, located immediately downstream of the intake structure.

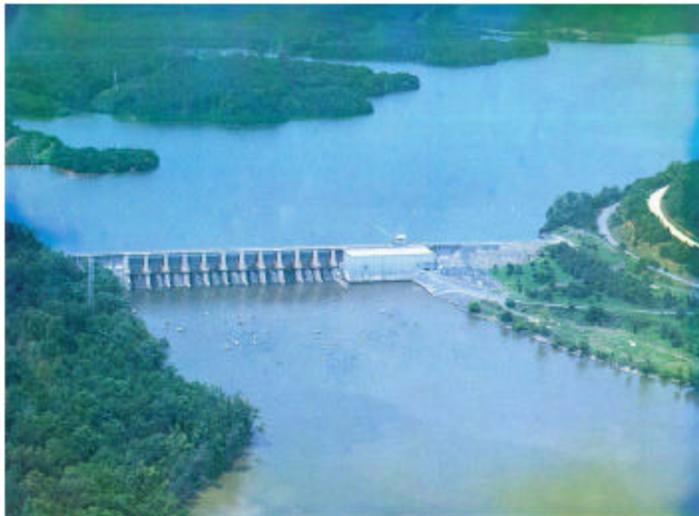
Tuckertown Dam includes concrete gravity sections, a rockfill section, and an earthfill section. The dam totals approximately 1,370 feet in length with a maximum height of approximately 76 feet. The dam consists of two embankments, three non-overflow gravity sections, a gated spillway section, and an integral intake/powerhouse section. The rockfill embankment is located between the east non-overflow section

and an east abutment. The earthfill embankment is a homogenous earthfill section at the west abutment. The non-overflow gravity sections are located at the east end of the powerhouse. The gate controlled spillway section is approximately 480 feet long.

The intake structure includes trashracks and six, fixed-wheel headgates. The powerhouse is a 204-foot-long grey, metal building on a concrete foundation and is located immediately downstream of the intake structure between the east non-overflow and middle non-overflow gravity sections.

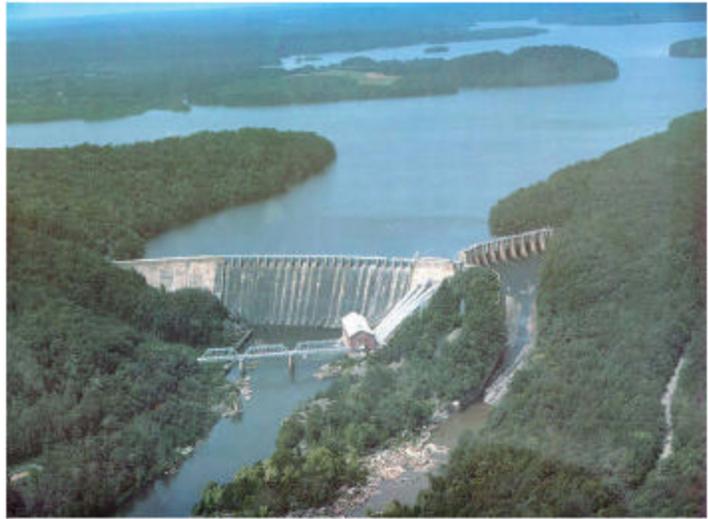
Narrows Dam consists of a main dam section and a bypass spillway section. The main dam section is a concrete gravity structure approximately 1,144 feet long with a maximum height of approximately 201 feet. The bypass spillway section is approximately 520 feet long. The main dam consists of a non-overflow gravity section, a gate-controlled spillway section, an intake section, a downstream powerhouse, and four steel penstocks. The non-overflow gravity section extends from the gated spillway section to the west river abutment. A training (wing) wall separates the non-overflow gravity section and the gate controlled spillway section. The gate-controlled spillway section is approximately 640 feet long with a trash gate at the northeast end.

The bypass spillway section is comprised of a non-overflow gravity section and a gate-controlled spillway section. The non-overflow gravity section extends from the bypass spillway to the east river abutment. The gate-controlled spillway section is approximately 430 feet long with a trash gate at the south end.

The powerhouse is a 213-foot-long, red-brick structure located immediately downstream of the intake section.

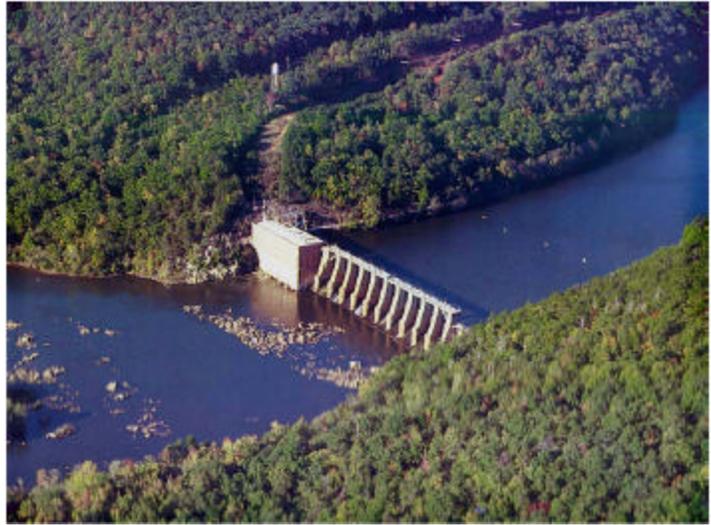
Falls Dam is a concrete gravity structure approximately 750 feet long with a maximum height of approximately 112 feet. The dam consists of a non-overflow gravity section, a gate-controlled spillway section, and an integral intake/powerhouse section. The non-overflow gravity section extends from the north end of the spillway section to the northern river abutment. The spillway section is approximately 525 feet long with a single trash gate.

The intake structure includes trashracks and vertical lift headgates. The powerhouse is a 189-foot long, red-brick structure located immediately downstream of the intake structure between the gate-controlled spillway section and river abutment.

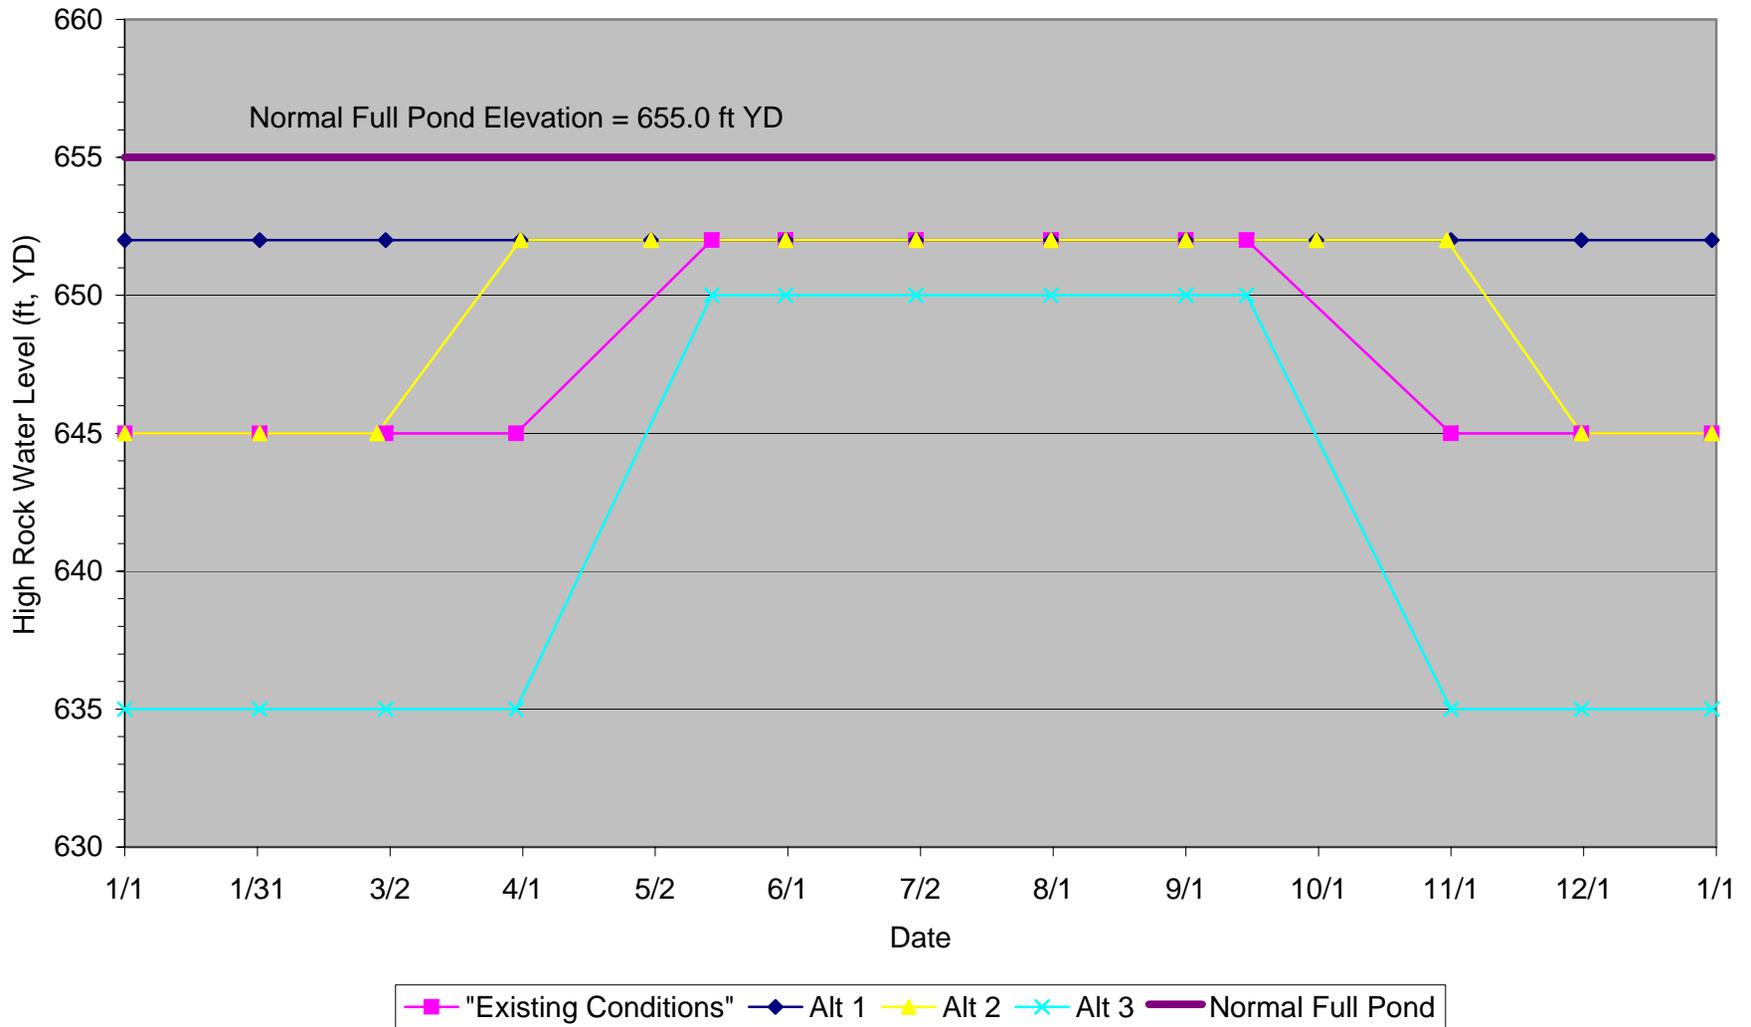
Figure 3-1
High Rock Water Level Alternatives

To evaluate the effect of alternative Project operations on aesthetics in the Project area, ERM examined three different water level scenarios for High Rock Reservoir. Figure 3-1 presents the three alternative water level scenarios in comparison with “existing conditions” and normal full pond.

As Figure 3-1 indicates, Alternative 1 would maintain relatively high water levels year-round at approximately 3 feet below normal full pond. Alternative 2 would result in higher water levels in March, April, October, and November than existing conditions. Conversely, Alternative 3 would result in lower water levels all year than existing conditions and the winter drawdown would be approximately 10-foot lower than existing conditions.

Alternative 2 is a modification of existing reservoir operations. Under this alternative, APCI would raise water levels earlier in the spring (early March rather than early April) and would maintain the higher water levels later into the fall (early November rather than mid- September) before beginning the seasonal drawdown. By extending the period of higher water levels, APCI would provide relatively high water levels (maximum of three-foot drawdown) for about 92 percent of the annual recreational use at High Rock Reservoir, versus 63 percent under existing conditions (see ERM, 2004). This alternative would still retain, however, the same magnitude of seasonal drawdown (12 feet), albeit for a shorter duration, as existing conditions. This seasonal drawdown still adversely affects the aesthetics of the reservoir, especially for year-round waterfront residents (approximately 55 percent of total waterfront residents). Alternative 2 would improve the aesthetics of the reservoir, but the reservoir would remain only “somewhat compatible” with the area’s Scenic Integrity rating of Low.

Alternative 3 could potentially result in lower water levels during the entire year in comparison with existing conditions. The potential magnitude of the drawdown would increase from about 12 feet to as much as 20 feet during the fall and winter (November thru March), and from about 3 feet to as much as 5 feet during the spring and summer (May thru September). The large number of viewers (over 2,000 waterfront residences and 1.2 million recreation days), the magnitude of the seasonal drawdown (20 feet), the extent of the potential summer drawdown when recreational use is high (5 feet), and the duration of the drawdown collectively increase the severity of the aesthetic impact.

Water level Alternative 3 would degrade the aesthetics of the reservoir from “somewhat compatible” to “not compatible” with the area’s Scenic Integrity rating.

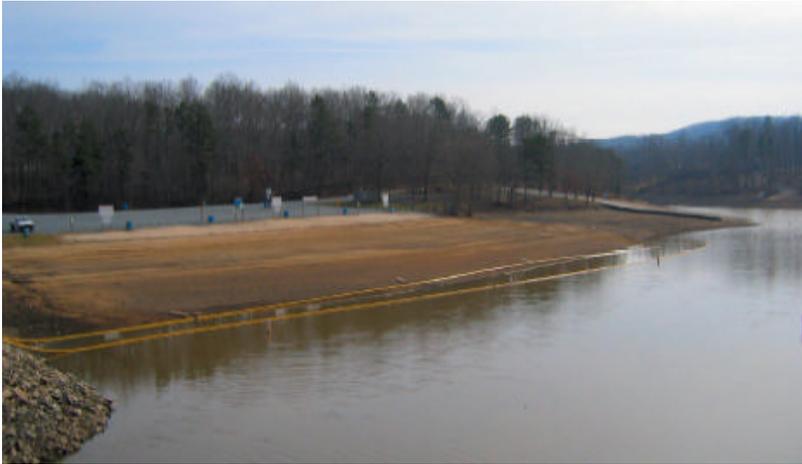
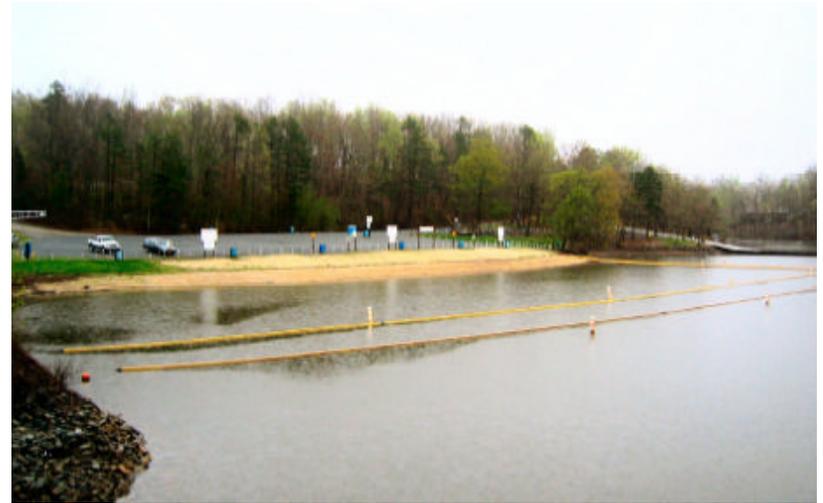
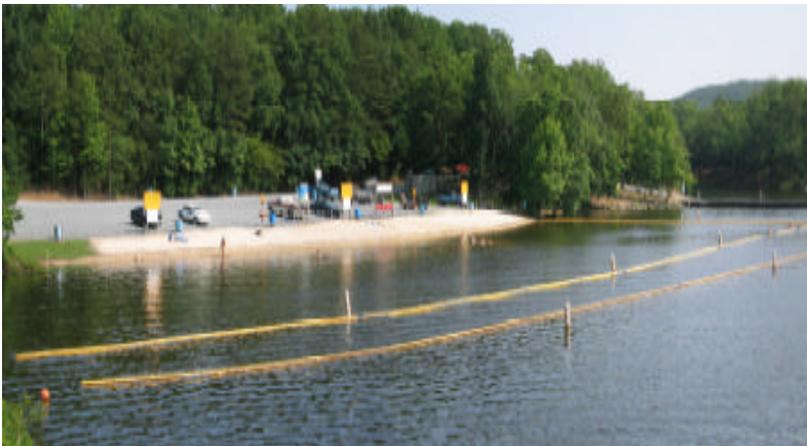
High Rock Reservoir
KOP HR 8: Flat Swamp Swim Access

View Description										Modifier Rating		
KOP	Viewer Location	Project Feature	Setting	Primary Viewer Group	Number of Viewers	Duration of View	Distance Zone	Orientation	Field of View	Spatial Dominance	Scale Contrast	Compatibility
HR 8	NC 8 Bridge over Flat Swamp Creek facing Flat Swamp Swim Access Area	High Rock Reservoir and Flat Swamp Swim Access	View from bridge of Flat Swamp Swimming area and beach.	Recreational users, motorists, boaters, anglers	High	Short-motorists Long-anglers/boaters, rec. users	Foreground	Indirect-motorists, Direct-boaters/anglers, rec. users	Wide	Co-Dominant	Moderate	Compatible, Somewhat compatible in winter, but area not used at that time

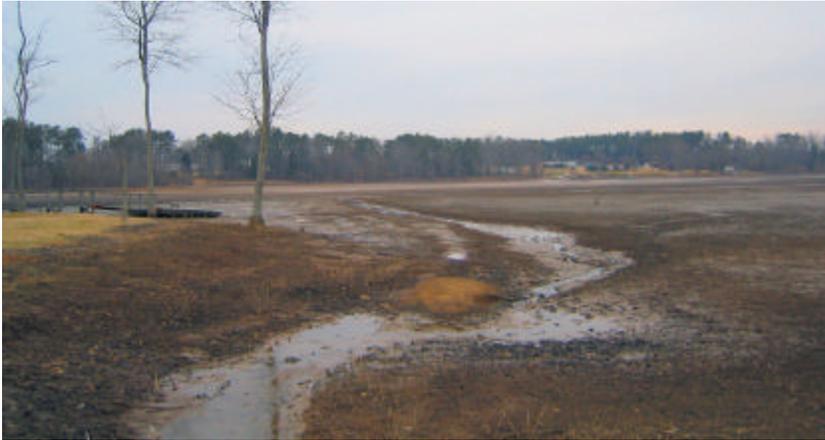
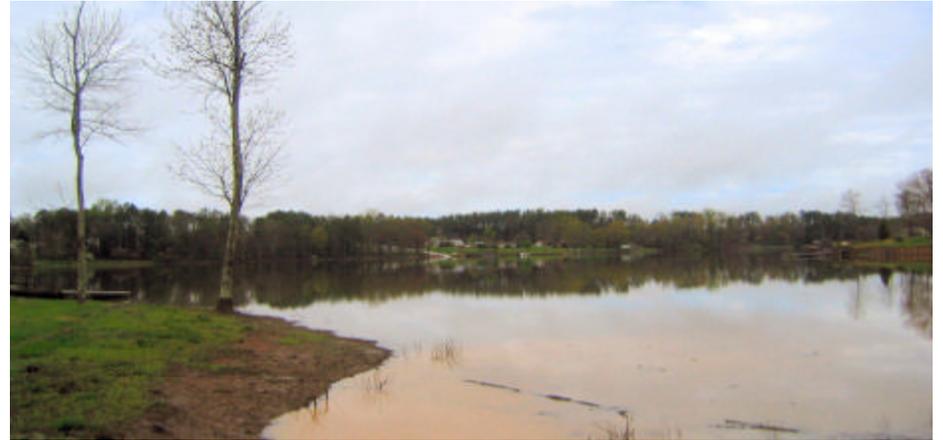
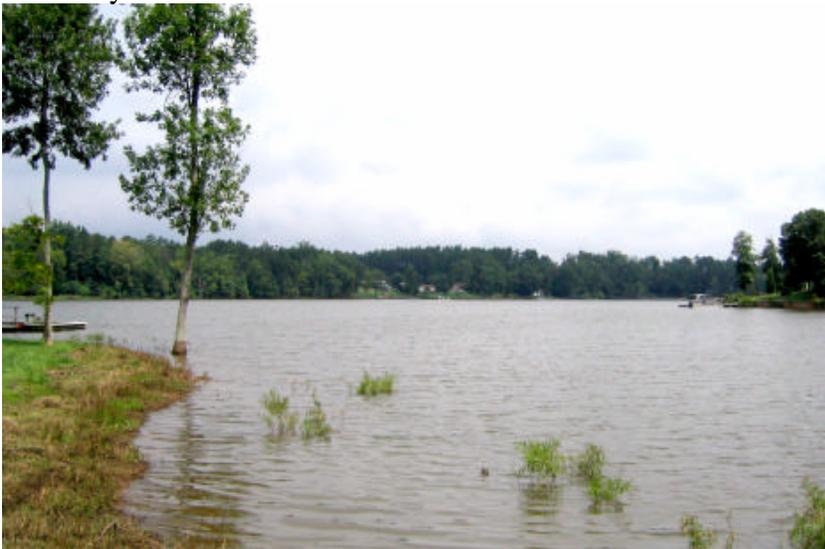
KOP HR 10: High Rock Boat and Ski Club

High Rock Lake is directly visible in the foreground from this KOP. A forested shoreline broken up by homes and yards is visible across the lake on the opposite shore. Boaters and recreational users are the primary viewers from this location. The winter drawdown completely dewatered this section of the lake revealing a large expanse of mud lake bottom. Higher levels of water turbidity are apparent in the spring.

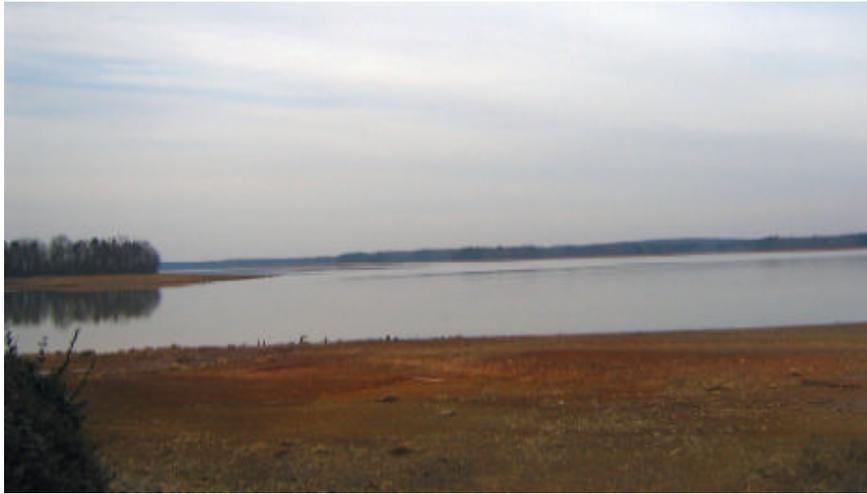
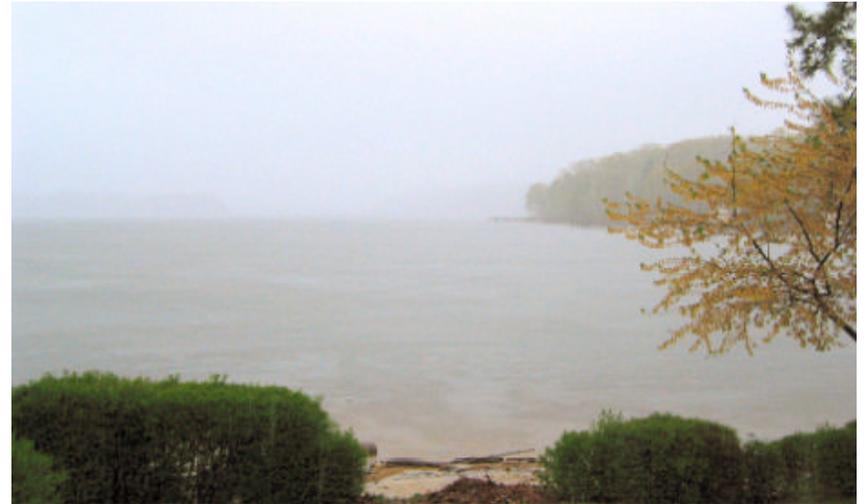
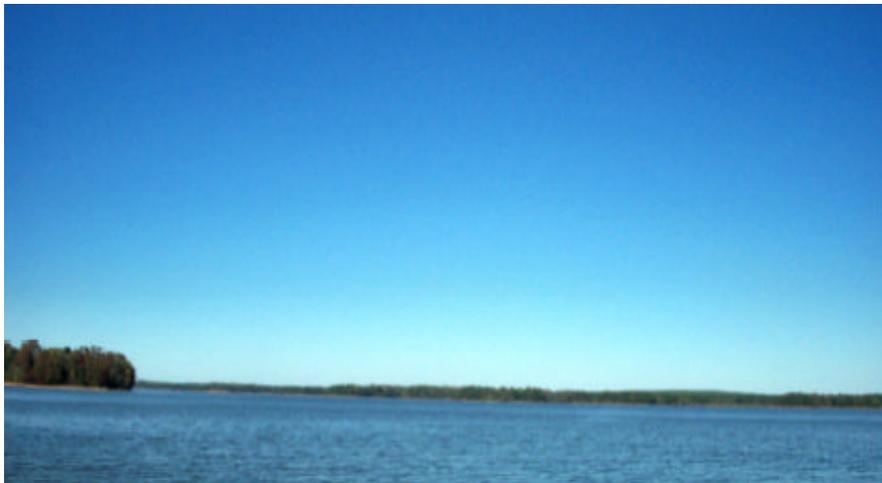
High Rock Reservoir
KOP HR 12: Panther Point

View Description										Modifier Rating		
KOP	Viewer Location	Project Feature	Setting	Primary Viewer Group	Number of Viewers	Duration of View	Distance Zone	Orientation	Field of View	Spatial Dominance	Scale Contrast	Compatibility
HR 12	Panther Point facing NE	High Rock Reservoir	View of High Rock Lake and distant forested shorelines.	Boaters, anglers	Moderate	Long	Foreground to background	Direct	Wide	Dominant	Moderate	Compatible, Winter drawdown is somewhat compatible

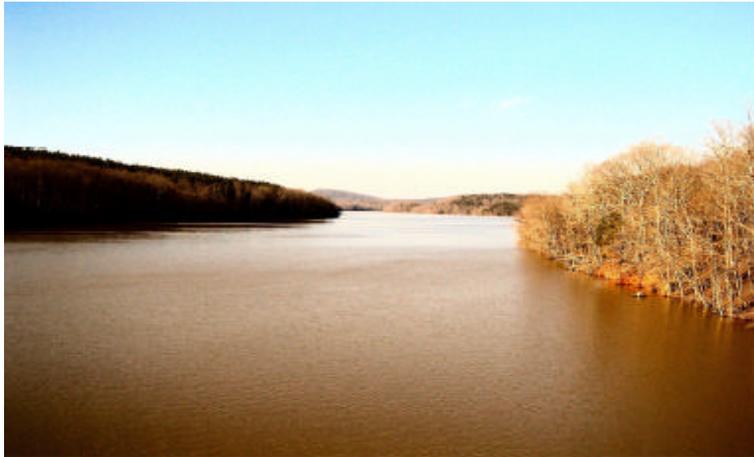
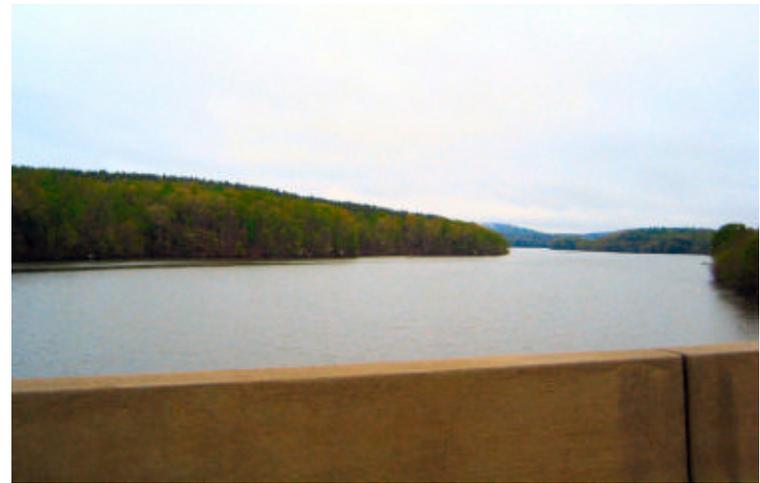
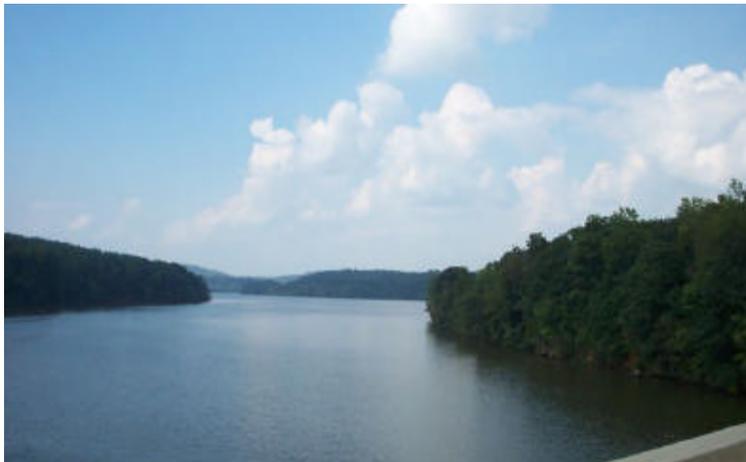
Tuckertown Reservoir
KOP T 4A: Highway 49 Upstream

View Description										Modifier Ratings		
KOP	Viewer Location	Project Feature	Setting	Primary Viewer Groups	Number of Viewers	Duration of View	Distance Zone	Orientation	Field of View	Spatial Dominance	Scale Contrast	Compatibility
T 4A	Highway 49 at Tuckertown Res. center of bridge upstream	Tuckertown Reservoir	Forested shorelines	Motorists, boaters, anglers	High	Motorists-short Boaters/anglers-long	Foreground to background	Motorists-peripheral, boaters and anglers-direct to peripheral	Narrow	Dominant	Minimal to moderate	Compatible

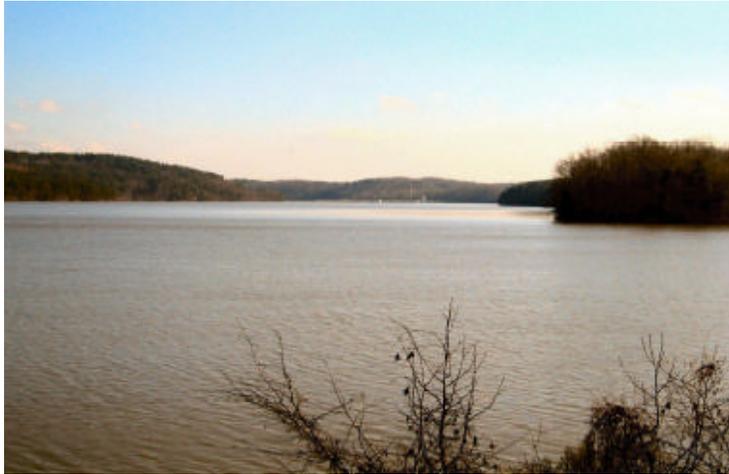
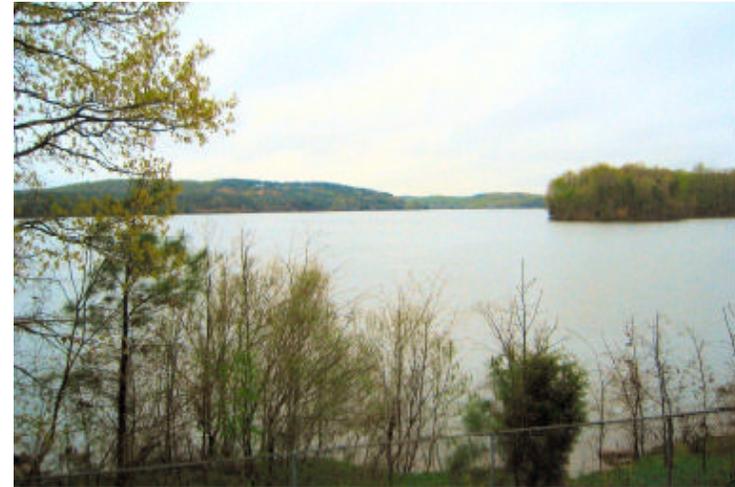
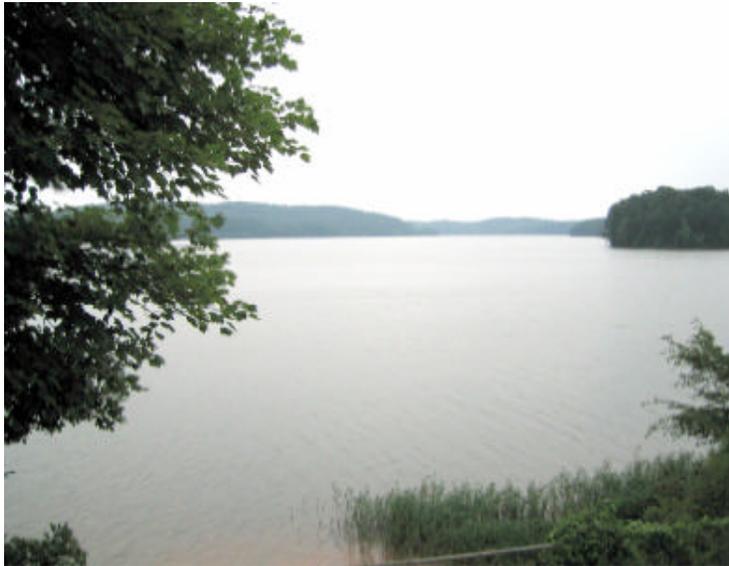
Tuckertown Reservoir
KOP T 4C: Highway 49 Scenic Pull-off

View Description										Modifier Ratings		
KOP	Viewer Location	Project Feature	Setting	Primary Viewer Groups	Number of Viewers	Duration of View	Distance Zone	Orientation	Field of View	Spatial Dominance	Scale Contrast	Compatibility
T 4C	Highway 49 Scenic Pulloff E bound. facing Tuckertown Reservoir. downstream.	Tuckertown Reservoir	Forested shorelines	Motorists	High	Short to long	Foreground to background	Direct	Wide	Dominant	Minimal	Compatible

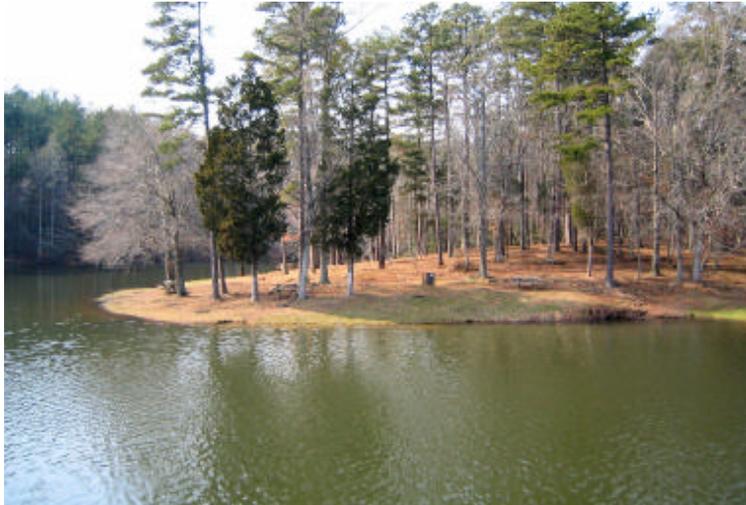
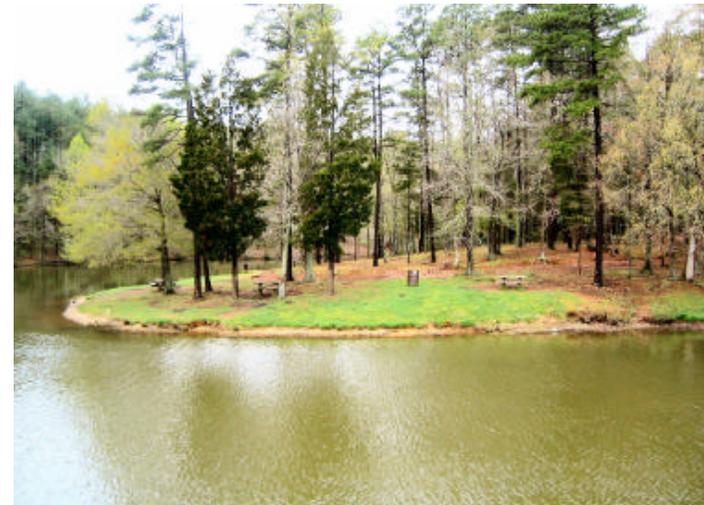
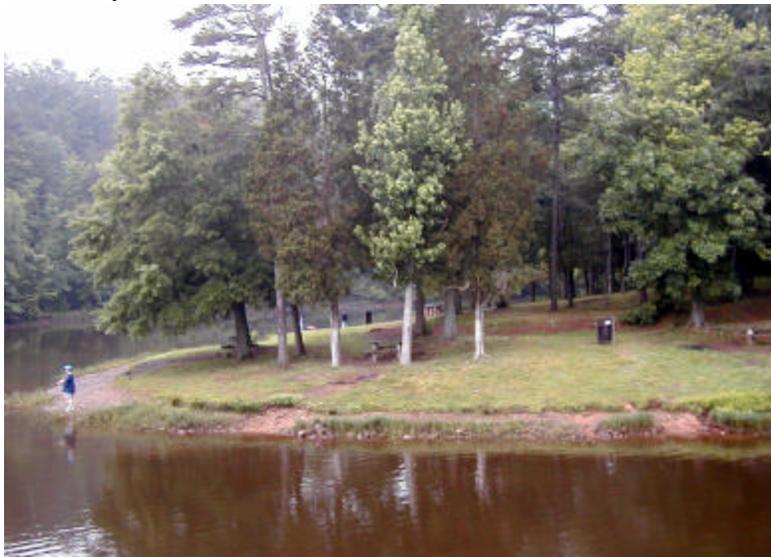
Tuckertown Reservoir
KOP T 5: Riles Creek Recreation Area

View Description										Modifier Ratings		
KOP	Viewer Location	Project Feature	Setting	Primary Viewer Groups	Number of Viewers	Duration of View	Distance Zone	Orientation	Field of View	Spatial Dominance	Scale Contrast	Compatibility
T 5	Stokes Ferry Road at Riles Creek from center of bridge upstream.	Riles Creek Recreation Area	Surrounding forest	Motorists, boaters, anglers	High	Motorists-short, boaters and anglers-long	Foreground	Motorists-peripheral, boaters and anglers-direct to peripheral	Narrow	Dominant	Minimal	Compatible

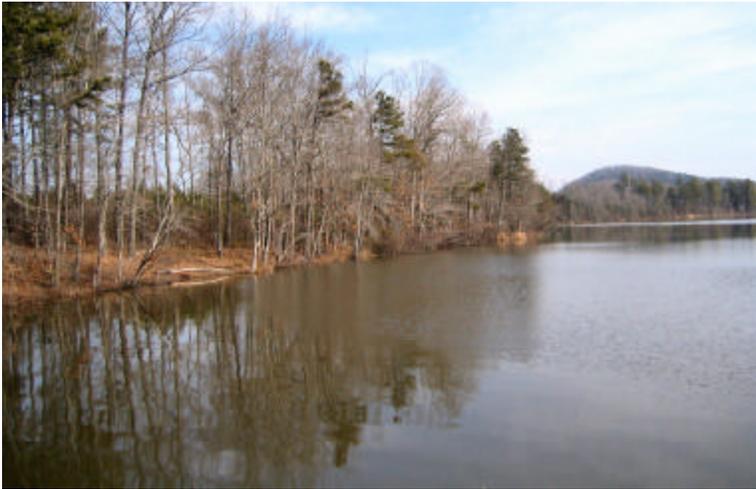
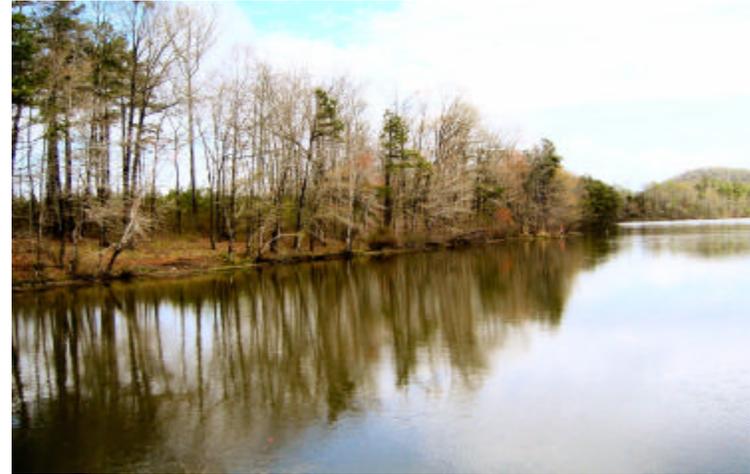
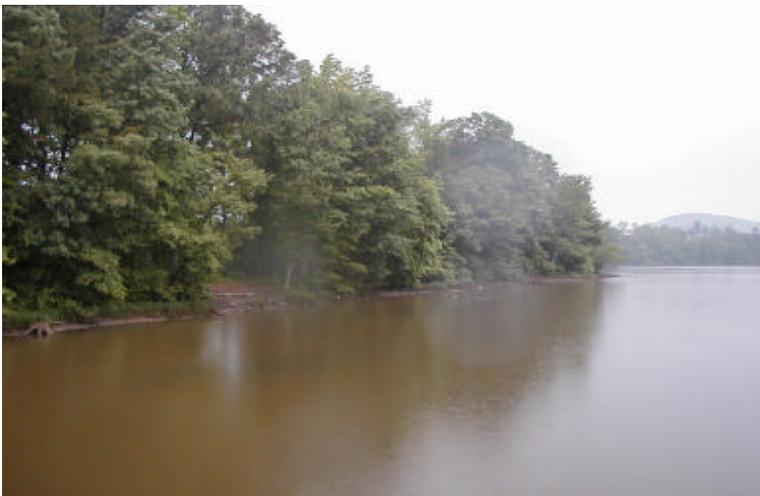
Tuckertown Reservoir
KOP T 6: Flat Creek to East

View Description										Modifier Ratings		
KOP	Viewer Location	Project Feature	Setting	Primary Viewer Groups	Number of Viewers	Duration of View	Distance Zone	Orientation	Field of View	Spatial Dominance	Scale Contrast	Compatibility
T 6	River Road at Flat Creek, center of bridge downstream.	Flat Creek	Forested shorelines	Motorists, boaters, anglers	Low	Motorists-short, boaters and anglers-long	Foreground to middleground	Motorists-peripheral, boaters and anglers-direct to peripheral	Narrow	Co-Dominant	Minimal	Compatible

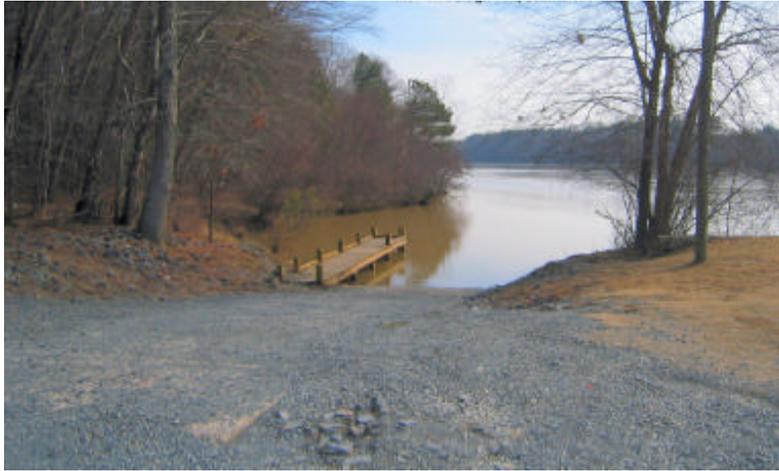
Tuckertown Reservoir
KOP T 8: Bringle Ferry Boat Access

View Description										Modifier Ratings		
KOP	Viewer Location	Project Feature	Setting	Primary Viewer Groups	Number of Viewers	Duration of View	Distance Zone	Orientation	Field of View	Spatial Dominance	Scale Contrast	Compatibility
T 8	Bringle Ferry Boat Access	Tuckertown Reservoir, Boat access	Forested shorelines.	Boaters, anglers	High	Long	Foreground to middleground	Direct	Narrow	Dominant	Minimal	Compatible

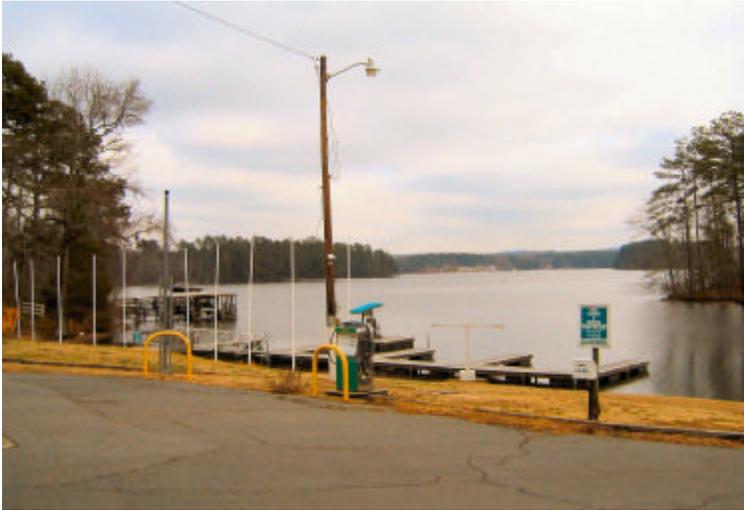
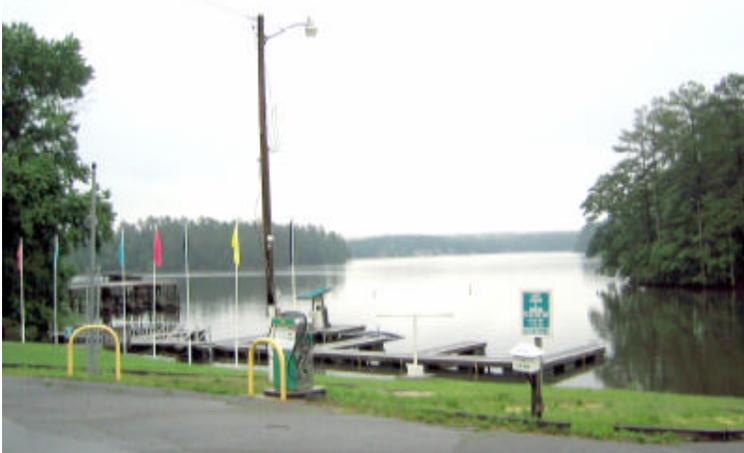
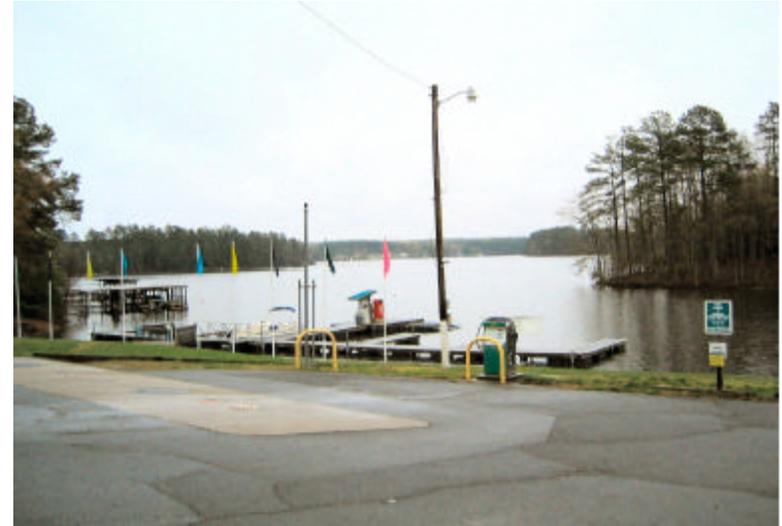
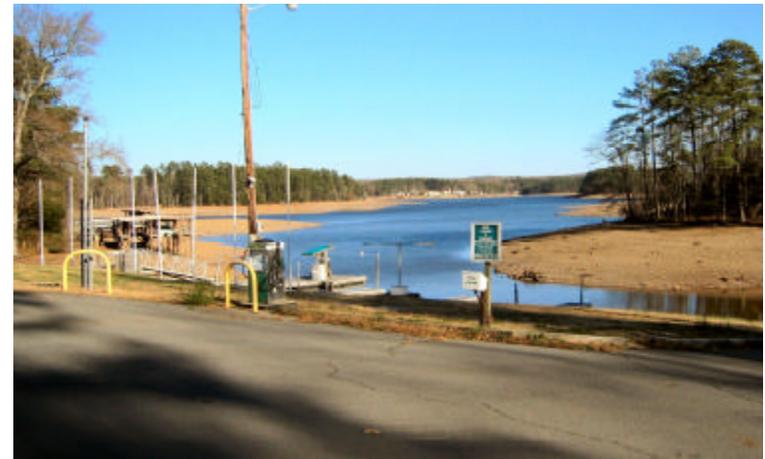
Narrows Reservoir
KOP NR 1: Fish Tails Marina

KOP	View Description									Modifier Rating		
	Viewer Location	Project Feature	Setting	Primary Viewer Group	Number of Viewers	Duration of View	Distance Zone	Orientation	Field of View	Spatial Dominance	Scale Contrast	Compatibility
NR 1	Fish Tails Marina facing NE	Narrows Reservoir	View from parking lot to floating docks, fuel pumps and reservoir.	Boaters, anglers	Moderate	Long	Foreground to middleground	Direct	Moderate	Co-Dominant	Moderate	Somewhat Compatible, not compatible during December drawdown

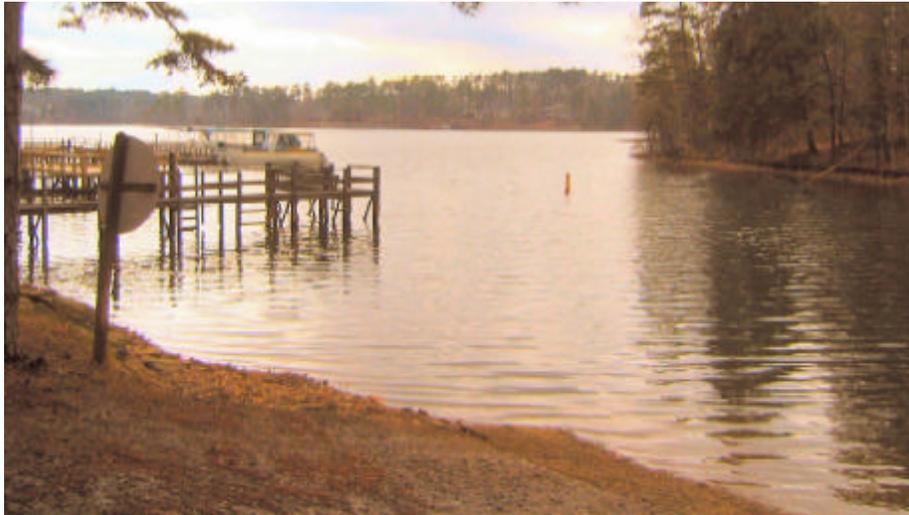
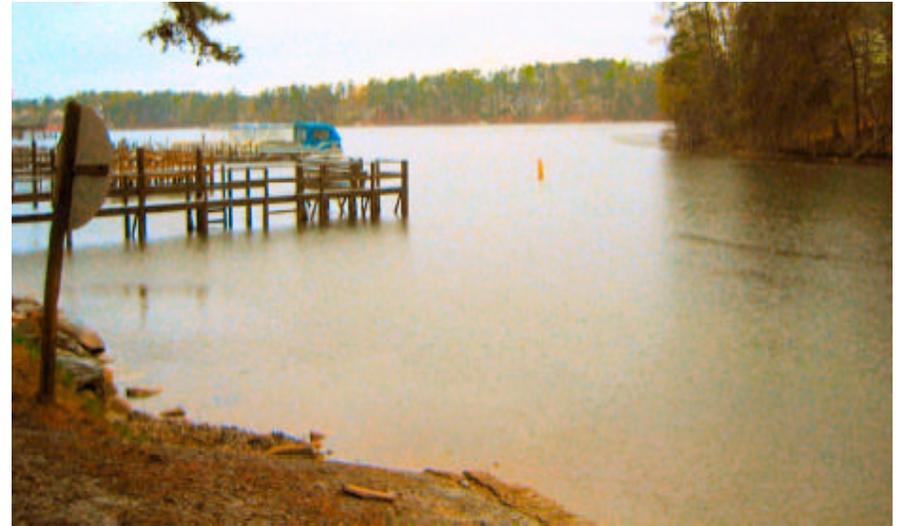
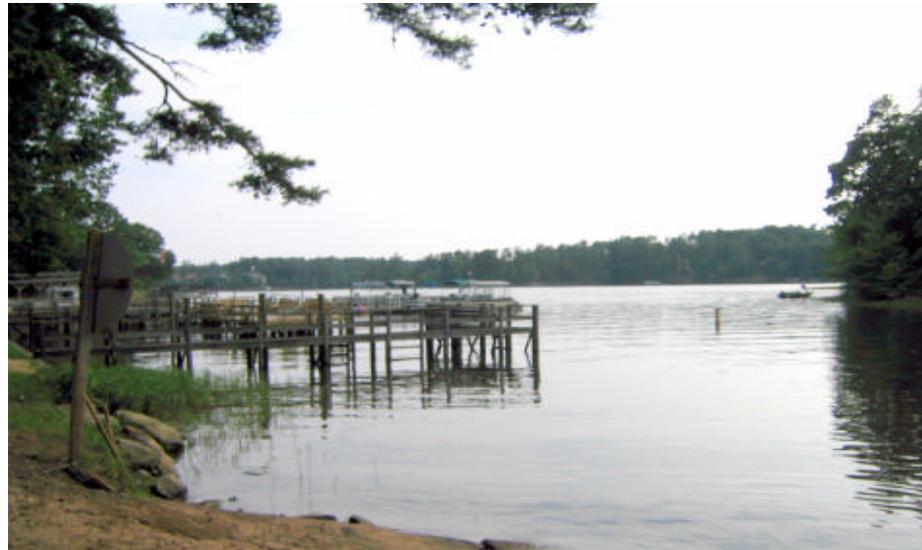
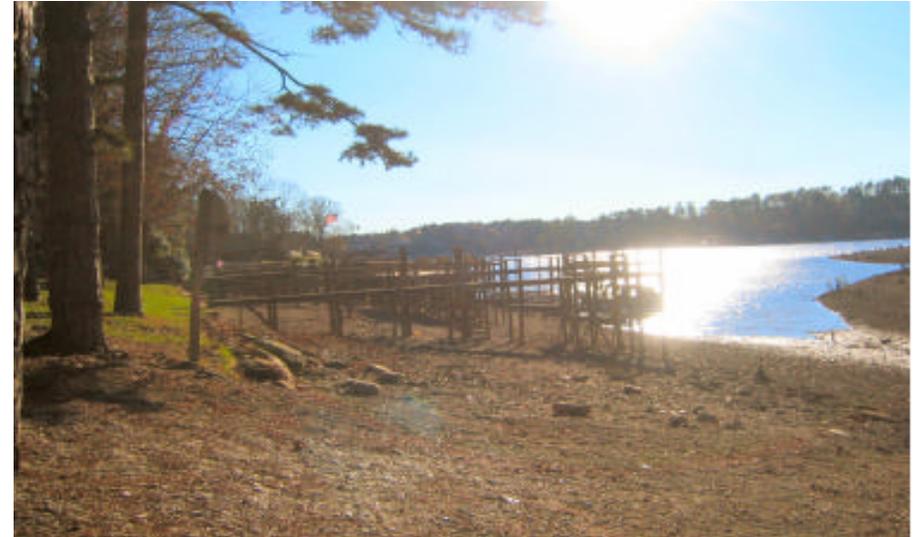
Narrows Reservoir
KOP NR 3: Lakemont Access Area

KOP	View Description								Modifier Rating			
	Viewer Location	Project Feature	Setting	Primary Viewer Group	Number of Viewers	Duration of View	Distance Zone	Orientation	Field of View	Spatial Dominance	Scale Contrast	Compatibility
NR 3	Lakemont Access Area facing SW.	Narrows Reservoir and Lakemont Access Area	View from access area of boat docks, reservoir and distant forested shoreline.	Boaters, Anglers	Moderate	Short to Long	Foreground	Direct	Narrow	Co-dominant	Moderate	Compatible, December drawdown is not compatible

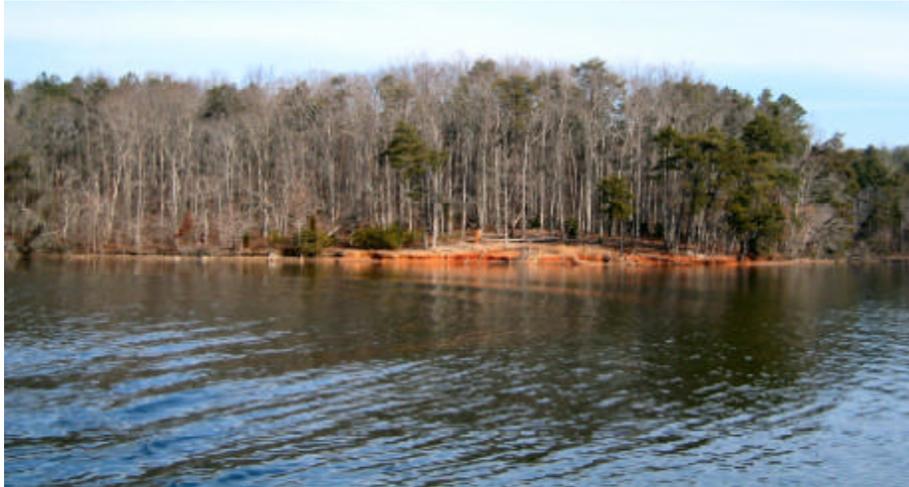
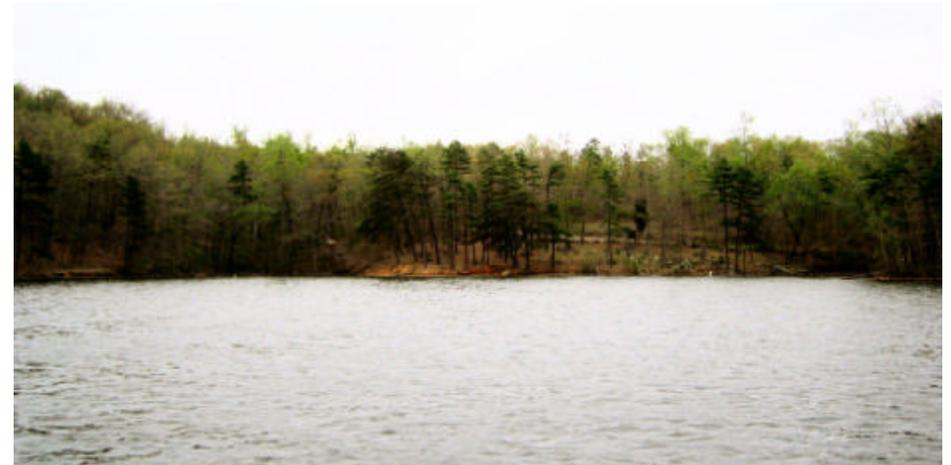
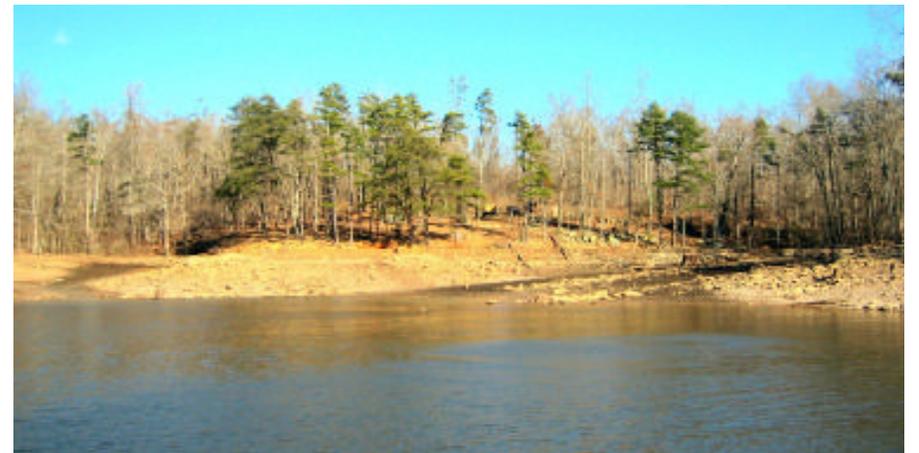
Narrows Reservoir
KOP NR 4: UNF Holt's Cabin

KOP	View Description									Modifier Rating		
	Viewer Location	Project Feature	Setting	Primary Viewer Group	Number of Viewers	Duration of View	Distance Zone	Orientation	Field of View	Spatial Dominance	Scale Contrast	Compatibility
NR 4	Narrows Reservoir offshore of Holt's Cabin facing NE.	Narrows Reservoir and UNF Holt's Cabin recreation area	View of UNF Holt's Cabin and surrounding forests from the reservoir.	Anglers, boaters	Low	Short to long	Foreground	Direct	Wide	Subordinate	Minimal	Compatible, December drawdown is not compatible

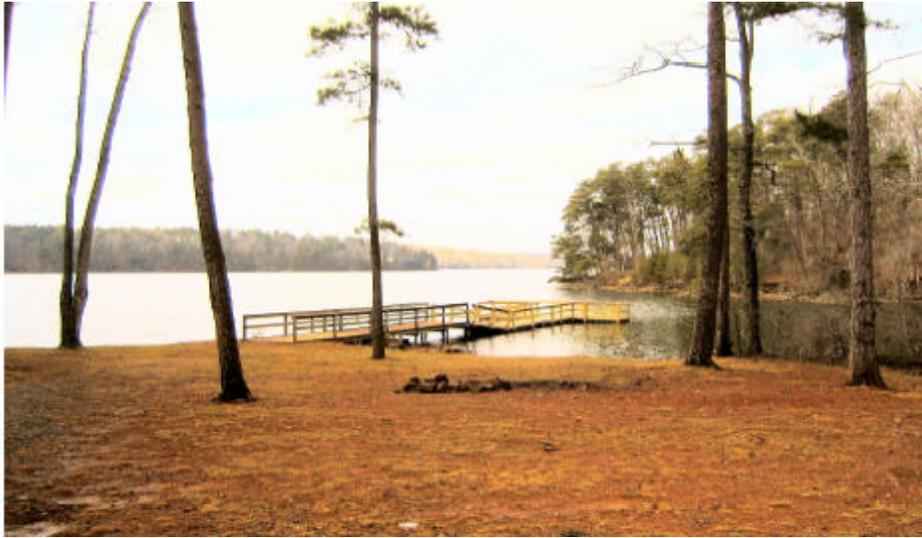
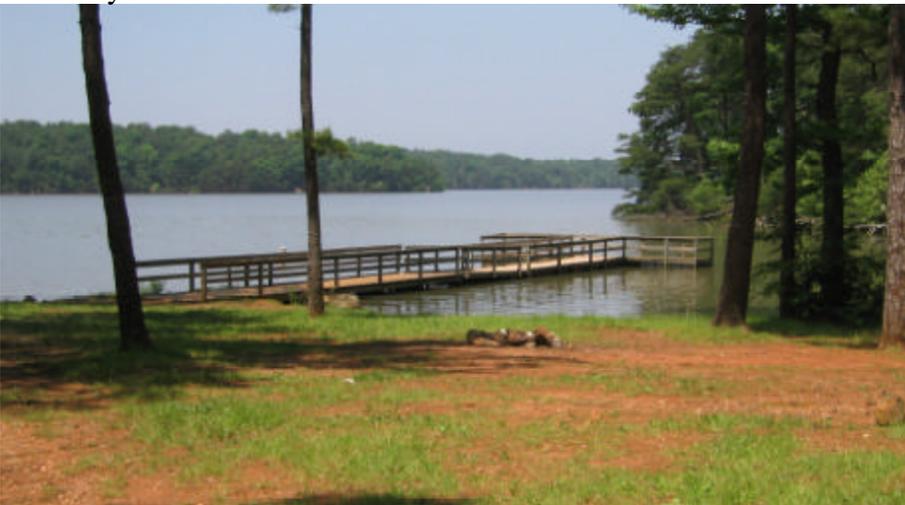
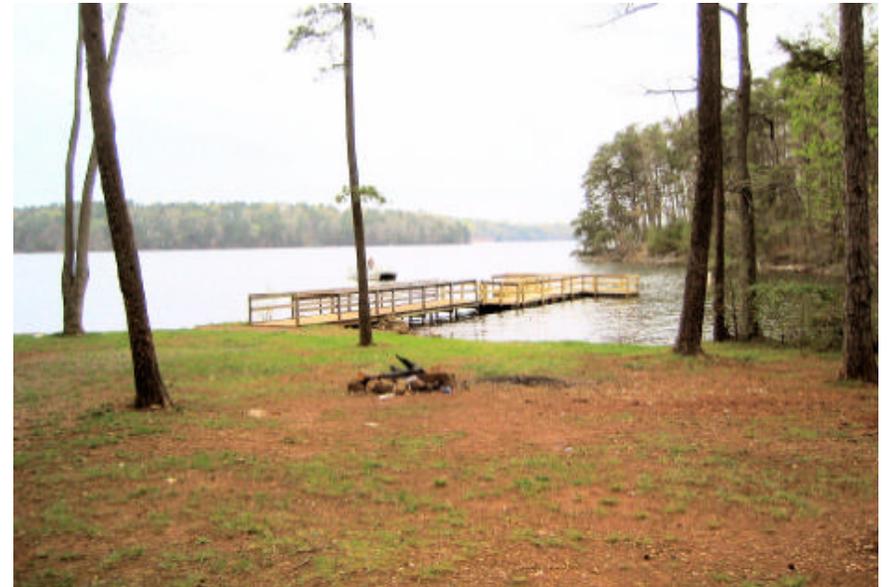
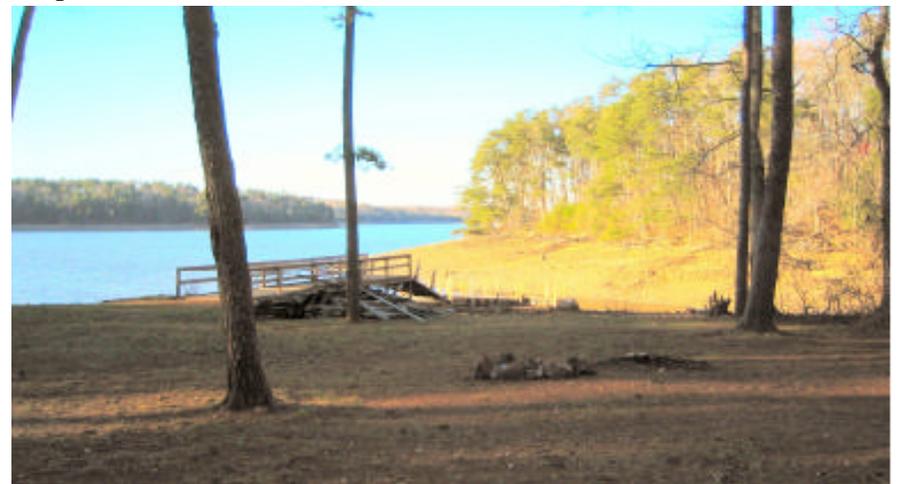
Narrows Reservoir
KOP NR 5: UNF Fishing Pier

KOP	View Description								Modifier Rating			
	Viewer Location	Project Feature	Setting	Primary Viewer Group	Number of Viewers	Duration of View	Distance Zone	Orientation	Field of View	Spatial Dominance	Scale Contrast	Compatibility
NR 5	UNF landward of fishing pier facing SSW.	Narrows Reservoir and UNF Fishing Pier	View of UNF Fishing Pier, reservoir and distant forested shorelines.	Recreational users, boaters, anglers	Moderate	Short to long	Foreground to middleground	Direct	Narrow	Subordinate	Minimal	Compatible, December drawdown is not compatible
