**Alcoa Power Generating Inc.
Yadkin Division**

Yadkin Project Relicensing (FERC No. 2197)

Project-Wide Aesthetic Study

Draft Report

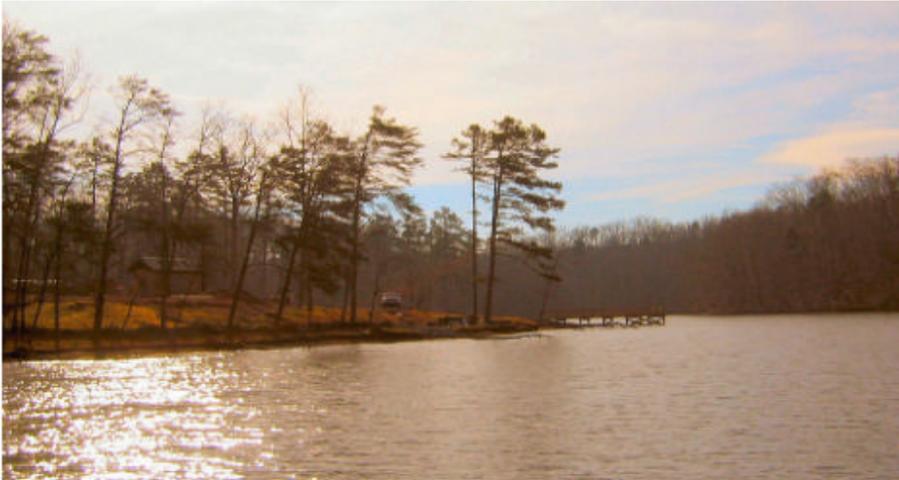
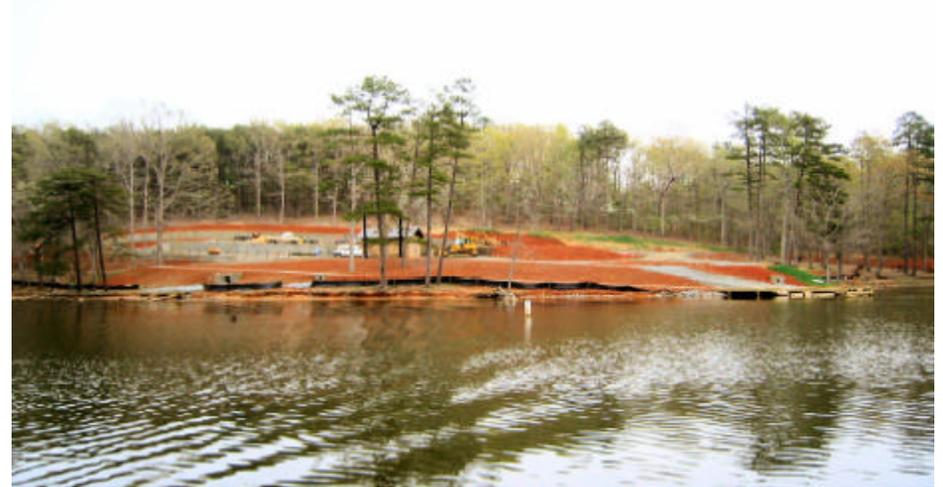
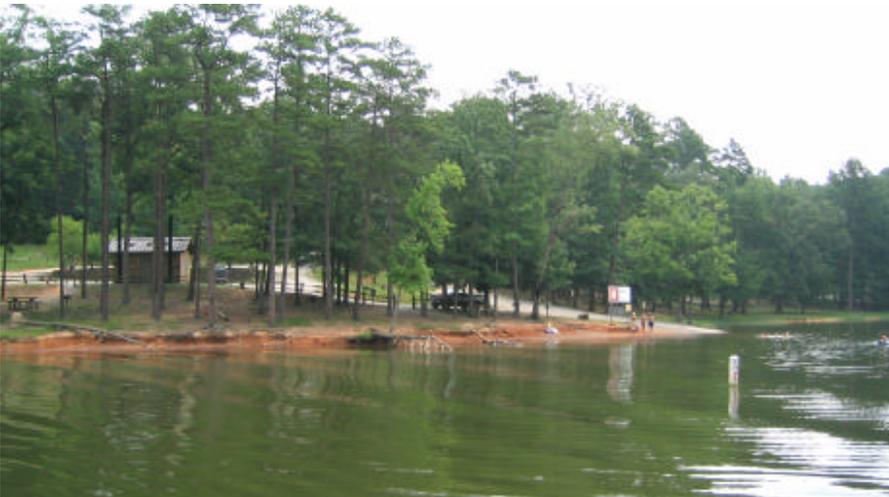
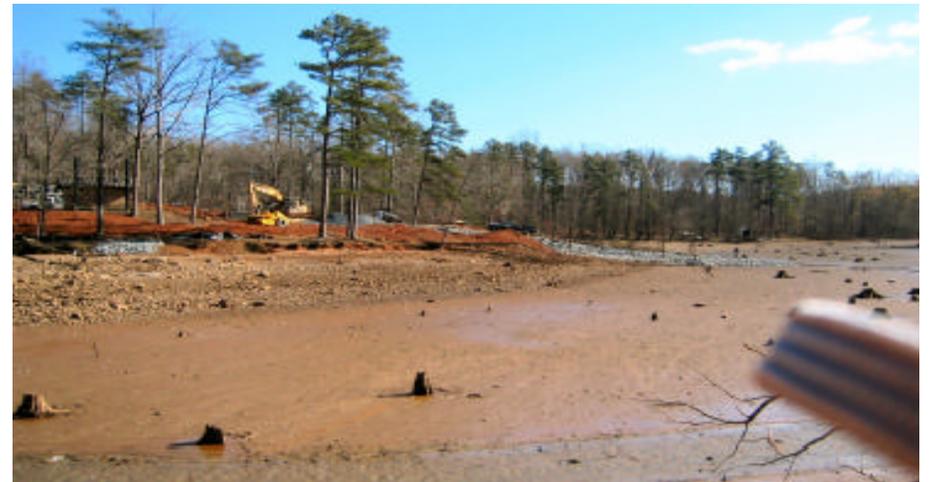
Narrows Reservoir
KOP NR 9: Cove Boat Landing

KOP	View Description									Modifier Rating		
	Viewer Location	Project Feature	Setting	Primary Viewer Group	Number of Viewers	Duration of View	Distance Zone	Orientation	Field of View	Spatial Dominance	Scale Contrast	Compatibility
NR 9	Narrows reservoir offshore of Cove Boat Landing facing SSE.	Narrows Reservoir and Cove Boat Landing	View of Cove Boat landing from Narrows Reservoir	Boaters, anglers	Moderate	Short to long	Foreground	Direct	Wide	Subordinate	Minimal	Somewhat Compatible, December drawdown is not compatible

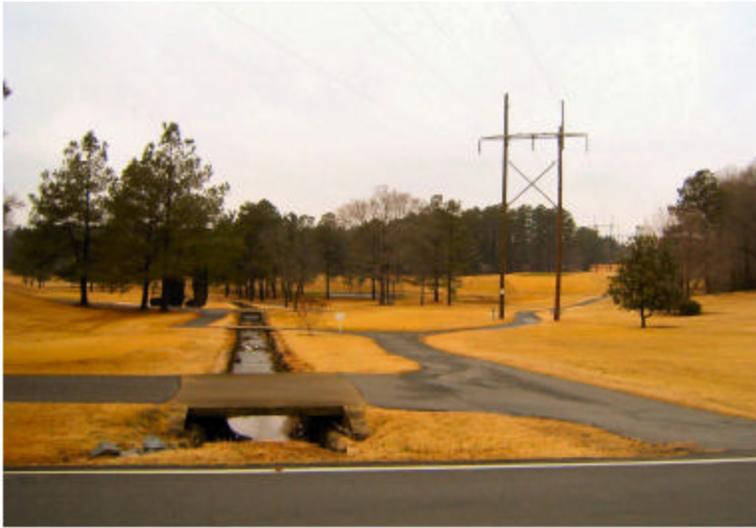
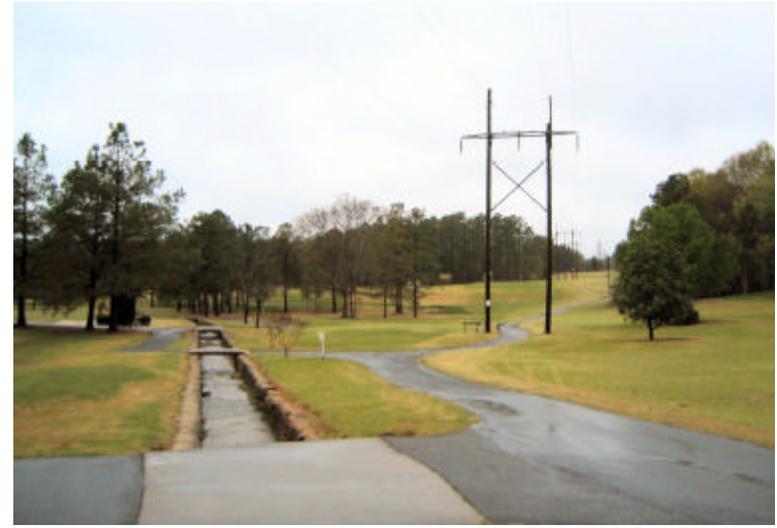
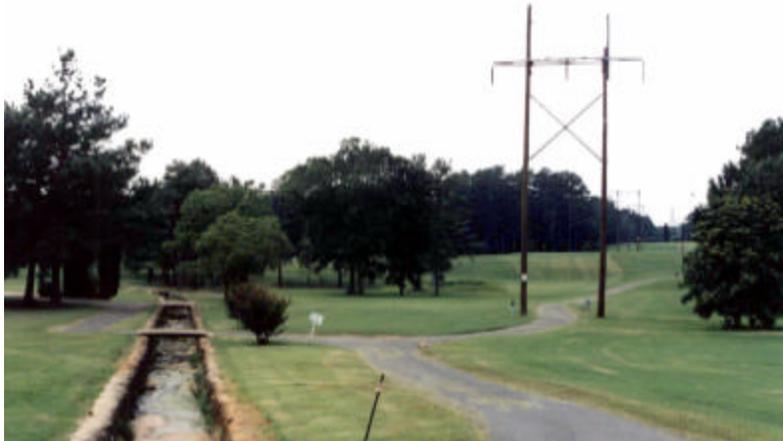
Narrows Reservoir
KOP NR 12: Transmission Lines

KOP	View Description									Modifier Rating		
	Viewer Location	Project Feature	Setting	Primary Viewer Group	Number of Viewers	Duration of View	Distance Zone	Orientation	Field of View	Spatial Dominance	Scale Contrast	Compatibility
NR 12	South of the town of Badin, facing north	Transmission Lines	View of Transmission lines	Motorists	Moderate	Short	Foreground	Indirect	Narrow	Co-dominant	Moderate	Somewhat compatible

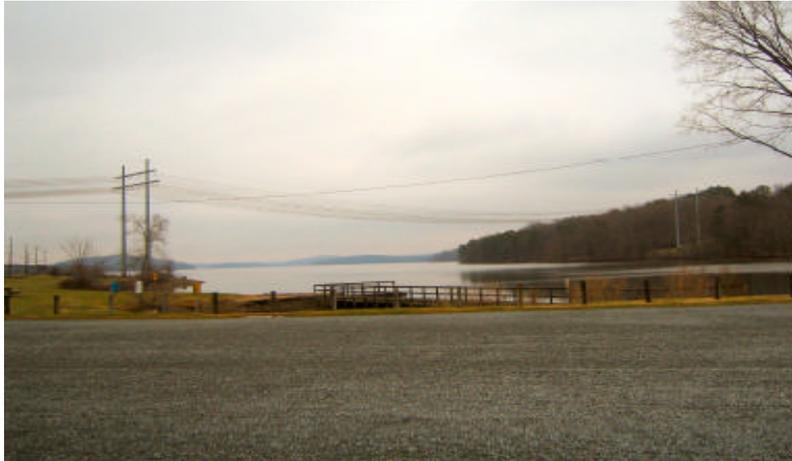
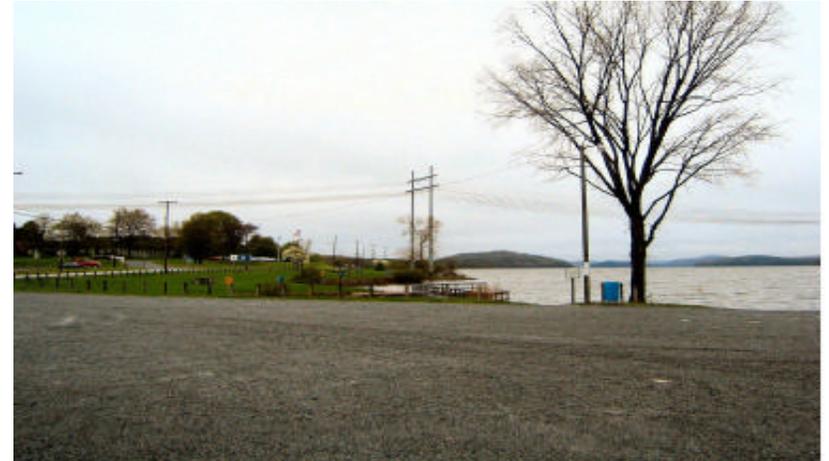
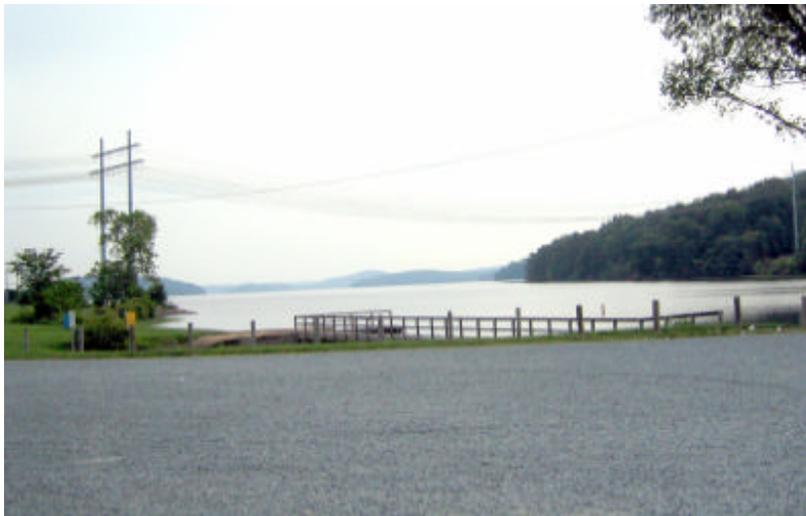
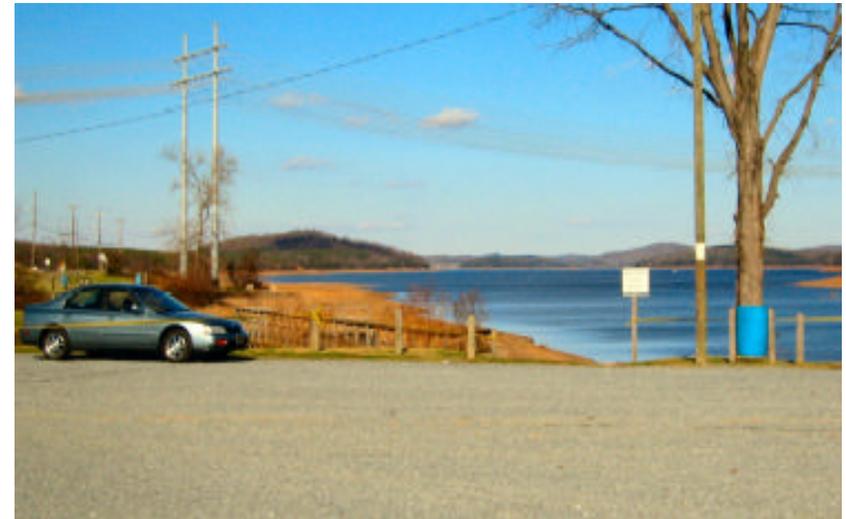
Narrows Reservoir
KOP NR 13: Badin Boat Access

KOP	View Description								Modifier Rating			
	Viewer Location	Project Feature	Setting	Primary Viewer Group	Number of Viewers	Duration of View	Distance Zone	Orientation	Field of View	Spatial Dominance	Scale Contrast	Compatibility
NR 13	Badin Boat Access facing N.	Narrows Reservoir and Badin Boat Access	View of Badin Boat Access with docks and overhead power lines.	Boaters, Anglers	High	Short to long	Foreground to background	Direct	Wide	Co-dominant	Moderate	Somewhat compatible, December drawdown is not compatible

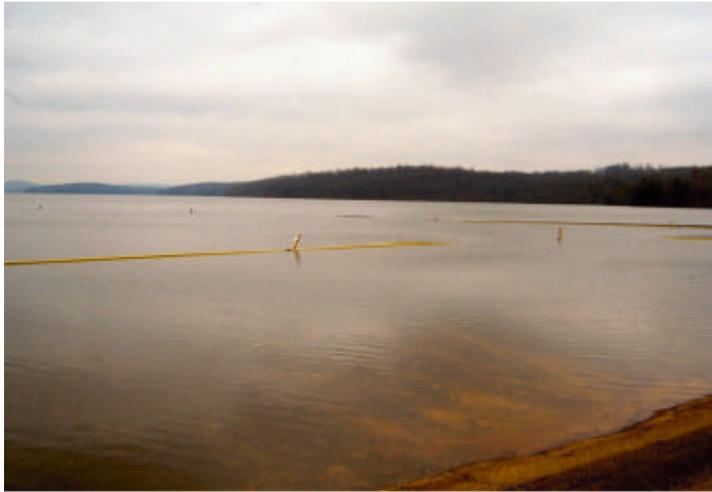
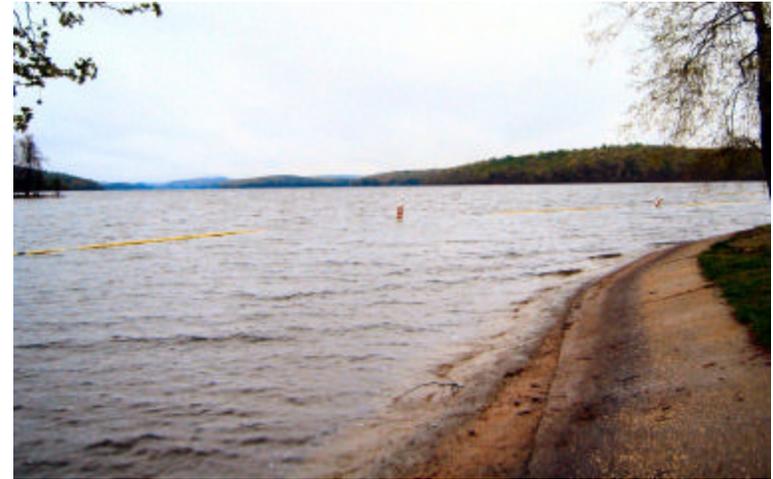
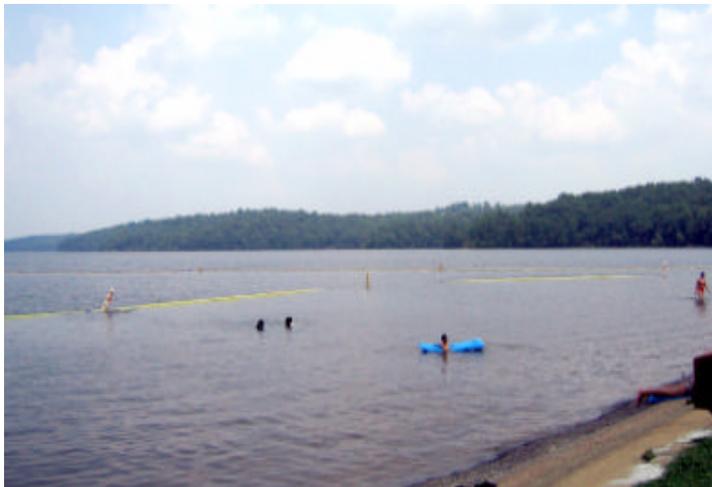
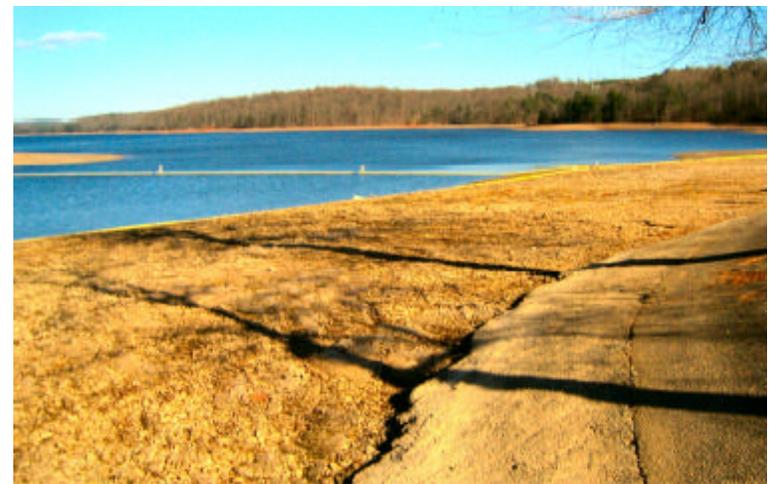
Narrows Reservoir
KOP NR 14: Badin Swim Area

KOP	View Description									Modifier Rating		
	Viewer Location	Project Feature	Setting	Primary Viewer Group	Number of Viewers	Duration of View	Distance Zone	Orientation	Field of View	Spatial Dominance	Scale Contrast	Compatibility
NR 14	Badin Swim Area facing SE.	Narrows Reservoir and Badin Swim Area	View of Narrows Reservoir Badin Swim Area.	Boaters, Anglers, Recreational users	High	Short to long	Foreground to Background	Direct	Wide	Subordinate	Minimal	Compatible, December drawdown is not compatible

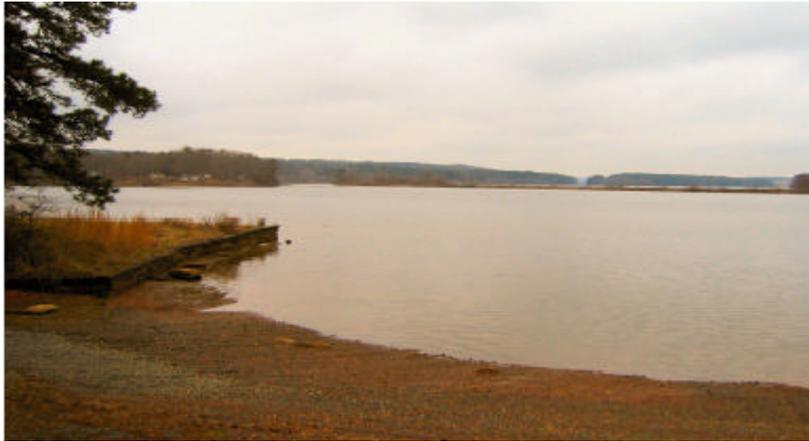
Narrows Reservoir
KOP NR 15: Palmerville Access

KOP	View Description									Modifier Rating		
	Viewer Location	Project Feature	Setting	Primary Viewer Group	Number of Viewers	Duration of View	Distance Zone	Orientation	Field of View	Spatial Dominance	Scale Contrast	Compatibility
NR 15	Palmerville Access facing N.	Narrows Reservoir and Palmerville Access	View of Palmerville Access Area.	Boaters, anglers	Low	Short to long	Foreground to background	Direct	Wide	Subordinate	Minimal	Somewhat Compatible, December drawdown is not compatible

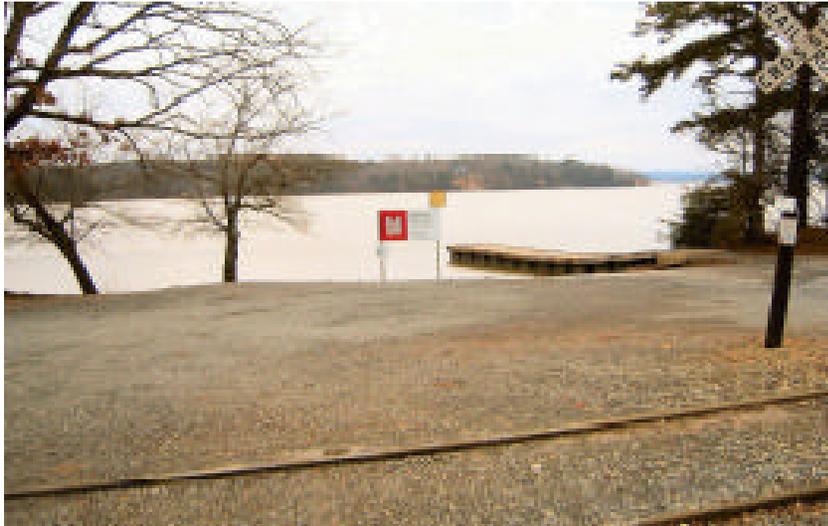
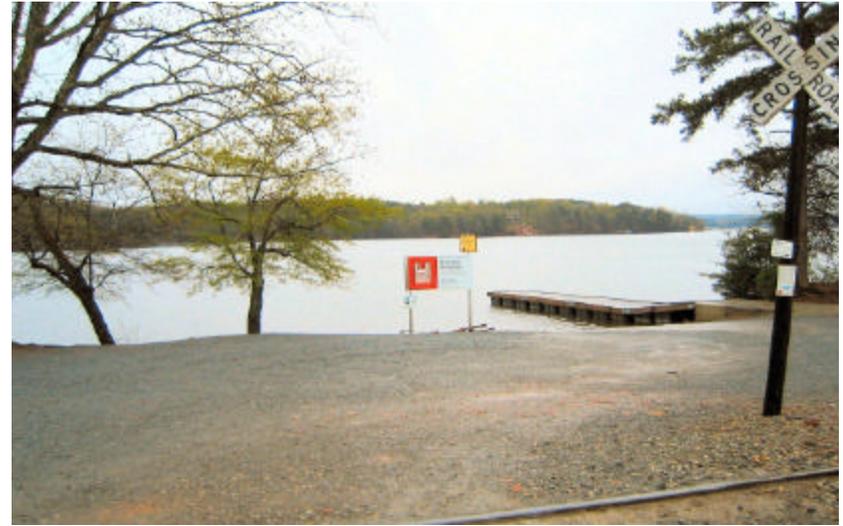
Narrows Reservoir
KOP NR 16: Old Whitney Boat Access

KOP	View Description									Modifier Rating		
	Viewer Location	Project Feature	Setting	Primary Viewer Group	Number of Viewers	Duration of View	Distance Zone	Orientation	Field of View	Spatial Dominance	Scale Contrast	Compatibility
NR 16	Old Whitney Boat Access facing NE.	Narrows Reservoir and Old Whitney Boat Access	View of Old Whitney Boat Access, floating dock and Alcoa sign.	Boaters, anglers	High	Long	Foreground to middleground	Direct	Moderate	Subordinate	Minimal	Compatible, December drawdown is not compatible
