**Alcoa Power Generating Inc.
Yadkin Division**

Yadkin Project Relicensing (FERC No. 2197)

**Uwharrie National Forest
Aesthetic Study**

Draft Report

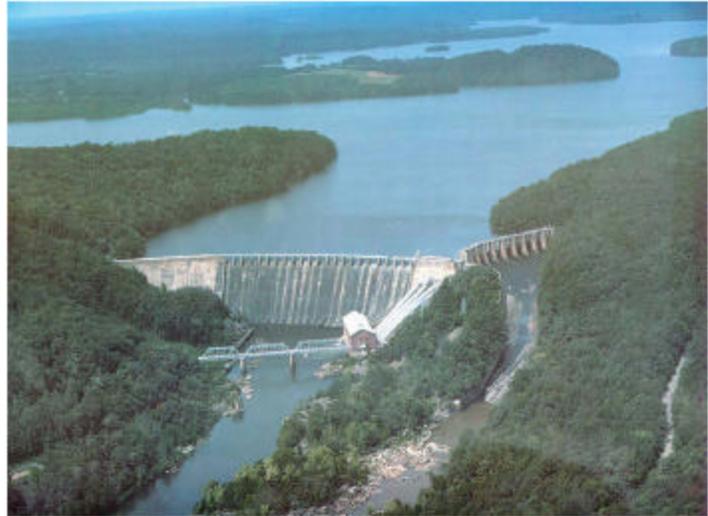
Narrows Dam consists of a main dam section and a bypass spillway section. The main dam section is a concrete gravity structure approximately 1,144 feet long with a maximum height of approximately 201 feet. The bypass spillway section is approximately 520 feet long. The main dam consists of a non-overflow gravity section, a gate-controlled spillway section, an intake section, a downstream powerhouse, and four steel penstocks. The non-overflow gravity section extends from the gated spillway section to the west river abutment. A training (wing) wall separates the non-overflow gravity section and the gate controlled spillway section. The gate-controlled spillway section is approximately 640 feet long with a trash gate at the northeast end.

The bypass spillway section is comprised of a non-overflow gravity section and a gate-controlled spillway section. The non-overflow gravity section extends from the bypass spillway to the east river abutment. The gate-controlled spillway section is approximately 430 feet long with a trash gate at the south end.

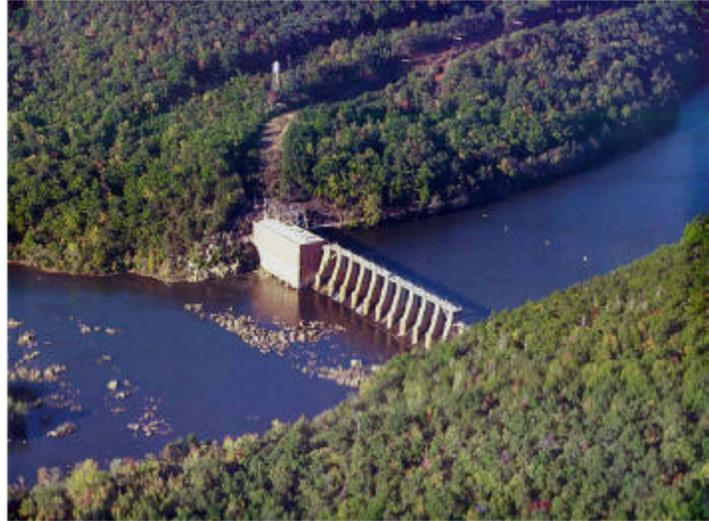
Falls Dam is a concrete gravity structure approximately 750 feet long with a maximum height of approximately 112 feet. The dam consists of a non-overflow gravity section, a gate-controlled spillway section, and an integral intake/powerhouse section. The non-overflow gravity section extends from the north end of the spillway section to the northern river abutment. The spillway section is approximately 525 feet long with a single trash gate.

The intake structure includes trashracks and vertical lift headgates. The powerhouse is a 189-foot long, red-brick structure located immediately downstream of the intake structure between the gate-controlled spillway section and river abutment.

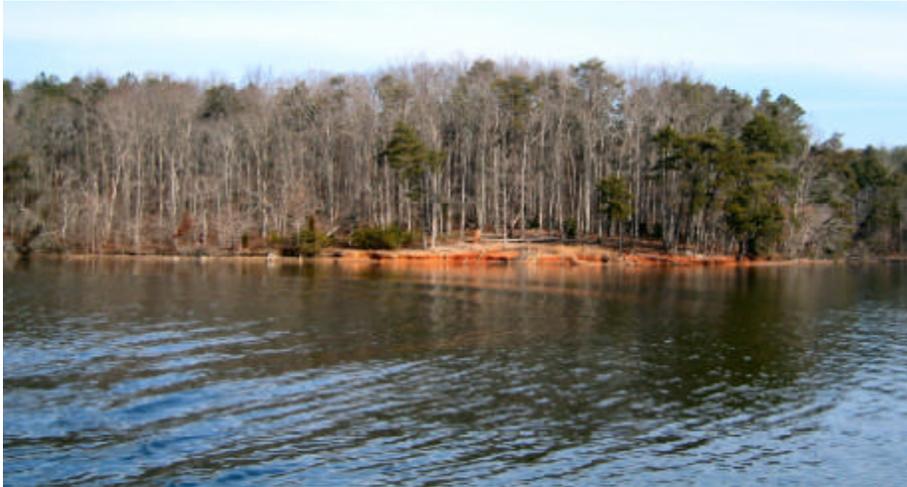
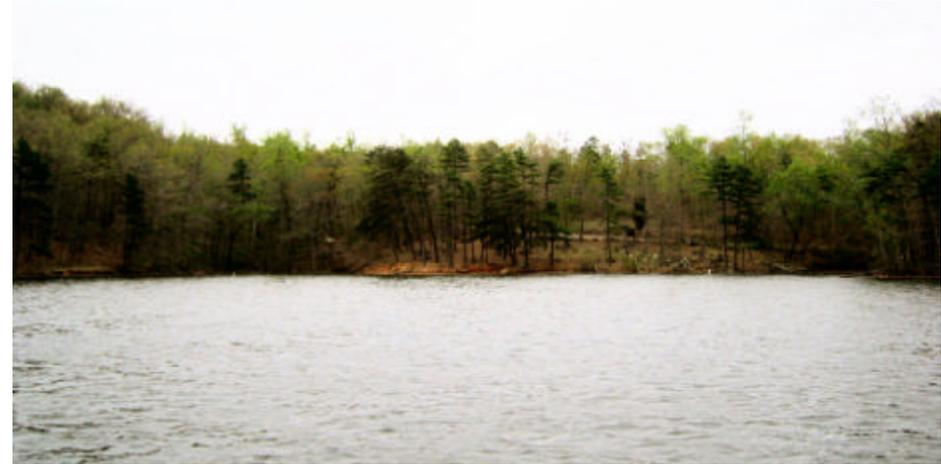
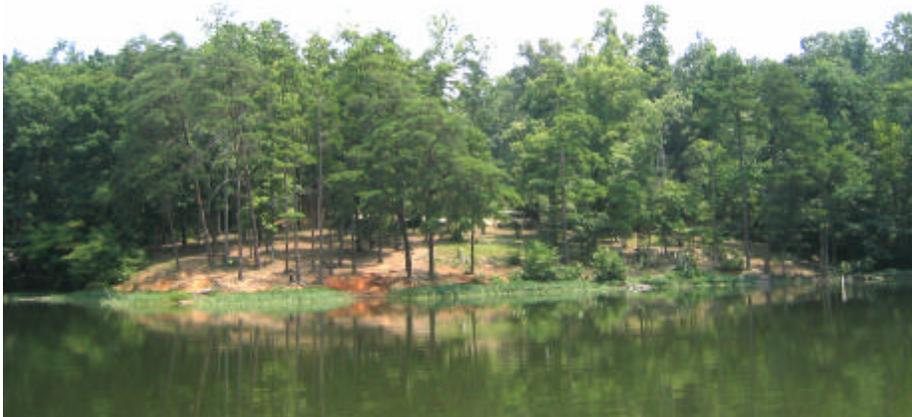
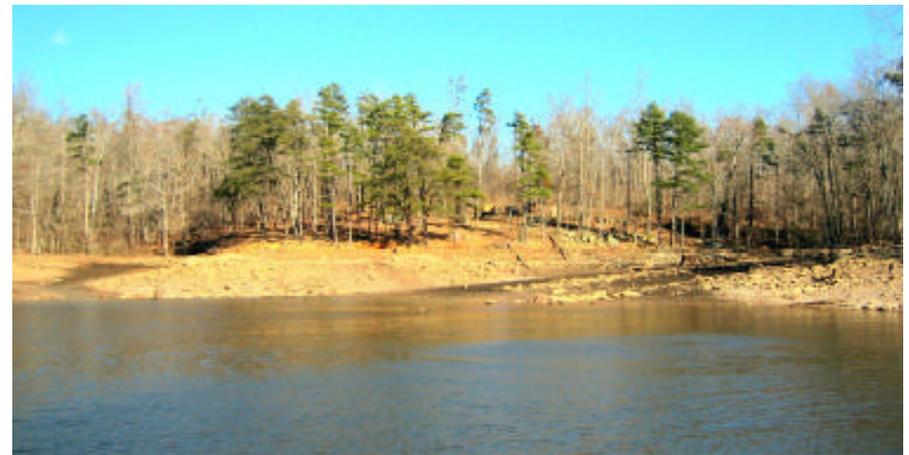
Narrows Reservoir
KOP NR 4: UNF Holt's Cabin

KOP	View Description									Modifier Rating		
	Viewer Location	Project Feature	Setting	Primary Viewer Group	Number of Viewers	Duration of View	Distance Zone	Orientation	Field of View	Spatial Dominance	Scale Contrast	Compatibility
NR 4	Narrows Reservoir offshore of Holt's Cabin facing NE.	Narrows Reservoir and UNF Holt's Cabin recreation area	View of UNF Holt's Cabin and surrounding forests from the reservoir.	Anglers, boaters	Low	Short to long	Foreground	Direct	Wide	Subordinate	Minimal	Compatible, December drawdown is not compatible

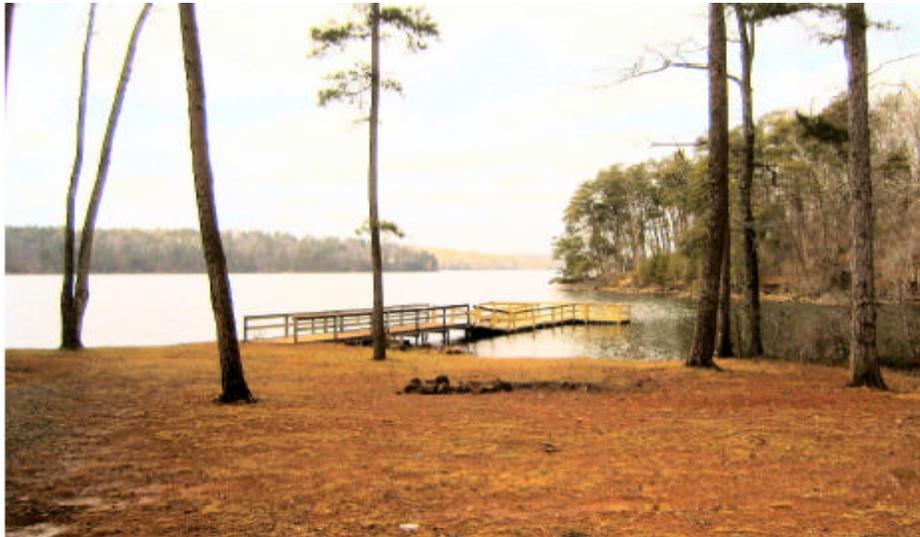
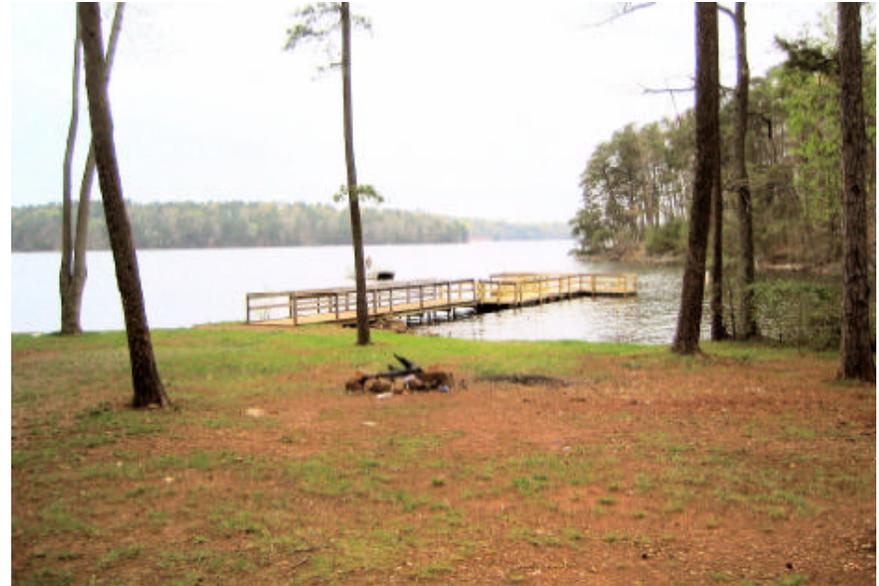
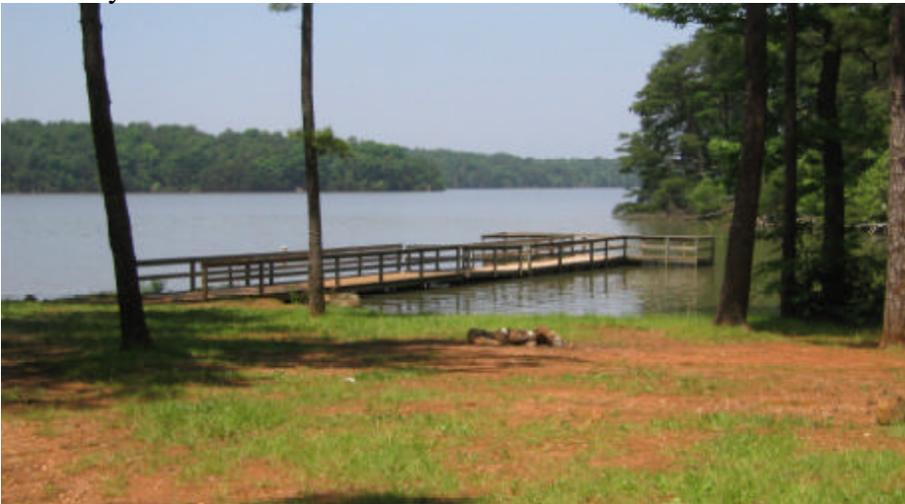
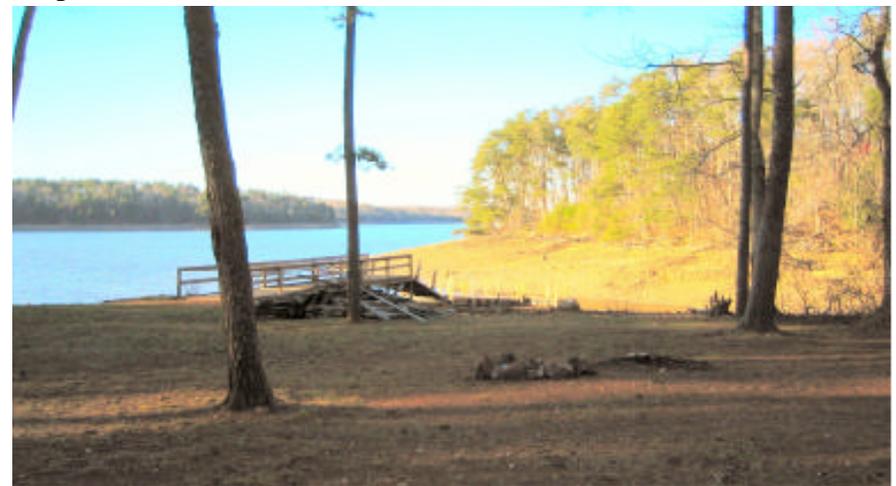
Narrows Reservoir
KOP NR 5: UNF Fishing Pier

View Description										Modifier Rating		
KOP	Viewer Location	Project Feature	Setting	Primary Viewer Group	Number of Viewers	Duration of View	Distance Zone	Orientation	Field of View	Spatial Dominance	Scale Contrast	Compatibility
NR 5	UNF landward of fishing pier facing SSW.	Narrows Reservoir and UNF Fishing Pier	View of UNF Fishing Pier, reservoir and distant forested shorelines.	Recreational users, boaters, anglers	Moderate	Short to long	Foreground to middleground	Direct	Narrow	Subordinate	Minimal	Compatible, December drawdown is not compatible

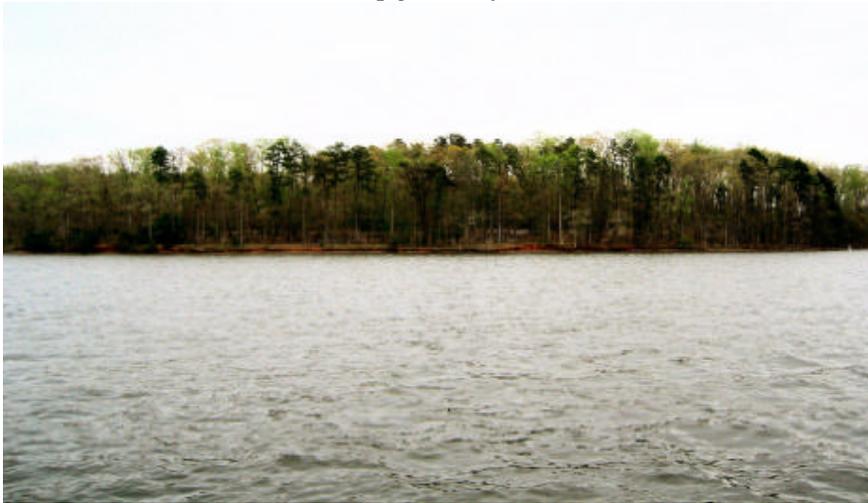
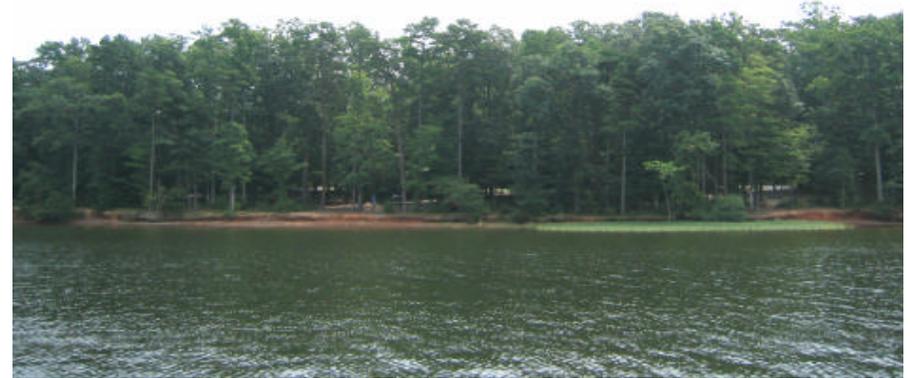
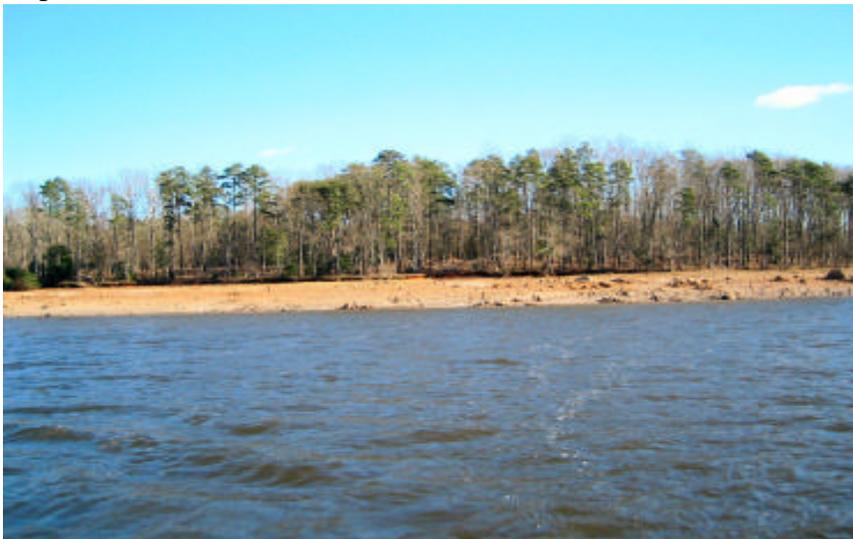
KOP NR 7: UNF Badin Campground from Water

The Badin Campground can be directly seen in the foreground from the water. The campground is surrounded by a thick forested shoreline of the Narrows Reservoir. The primary viewers are boaters and anglers and duration of view ranges from short to long. The view is natural and for much of the year natural vegetation screens most of the campground from view.

The Project facilities from this KOP appear natural and are compatible with the surrounds for most of the year. The campground is almost entirely hidden from view by the densely forested shoreline and this creates a natural and aesthetically pleasing view. At a 16-ft drawdown a rocky beach and eroded shoreline are exposed. A drawdown, similar to the 16-ft drawdown in December 2003 conducted as part of a fish and aquatics relicensing study, is not compatible with the Scenic Integrity of the area.

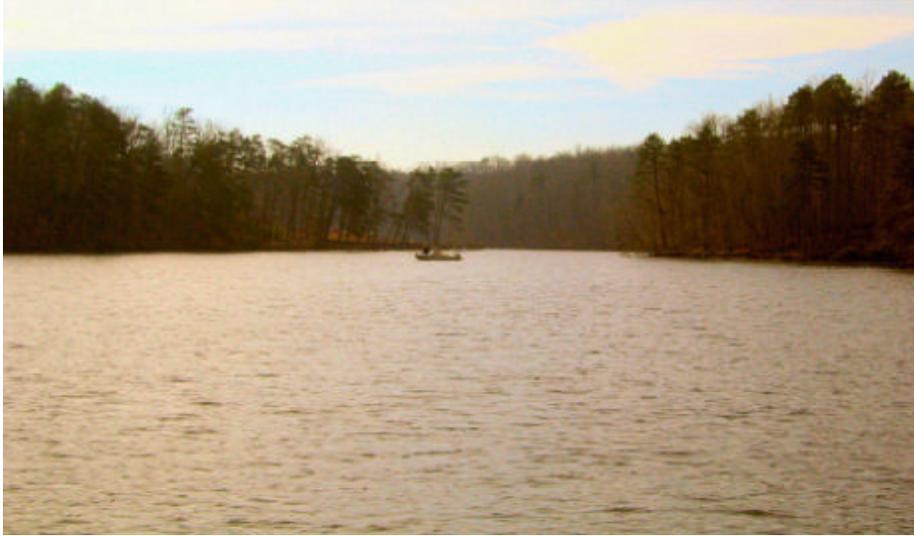
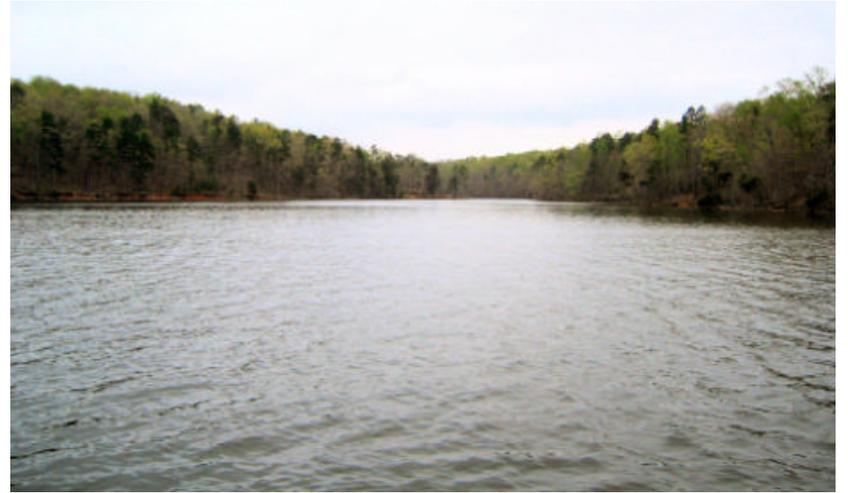
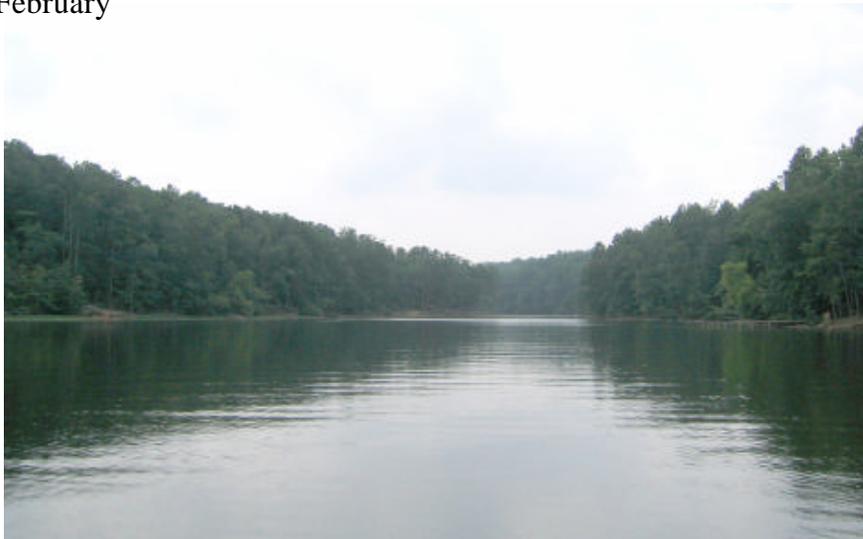
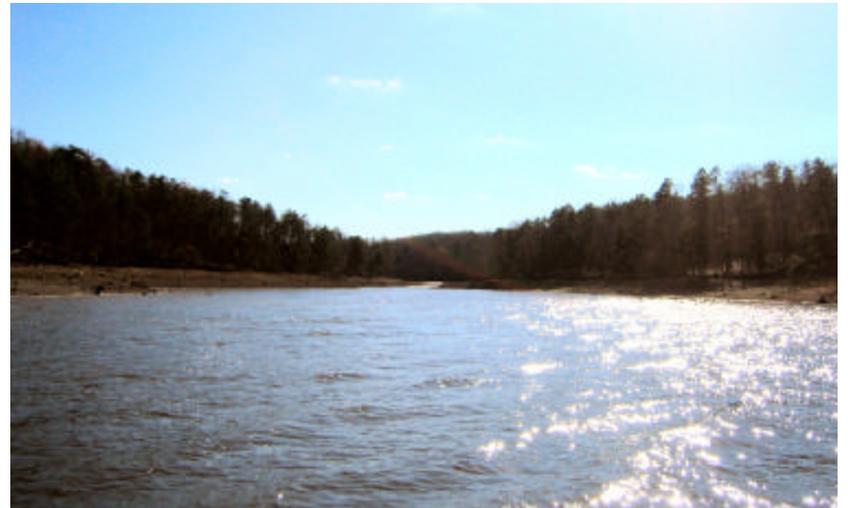
KOP NR 8: Cove Boat Landing from Water

Narrows Reservoir and the Cove Boat Landing are directly visible from the foreground to the middleground from this KOP. There is a wide view of the thick forested shorelines on either side of the reservoir with low, rolling hills in the distance. Boaters and anglers are the primary viewers from the KOP and view durations are short to long with a moderate number of viewers especially in peak recreational seasons.

The reservoir appears natural and is fully compatible with the surroundings for most of the year. The reservoir combines harmoniously with the setting to create an attractive view. At a 16-ft drawdown, the lake bottom is exposed along the shorelines. A drawdown, similar to the 16-ft drawdown in December 2003 conducted as part of a fish and aquatics relicensing study, is not compatible with the Scenic Integrity of the area.

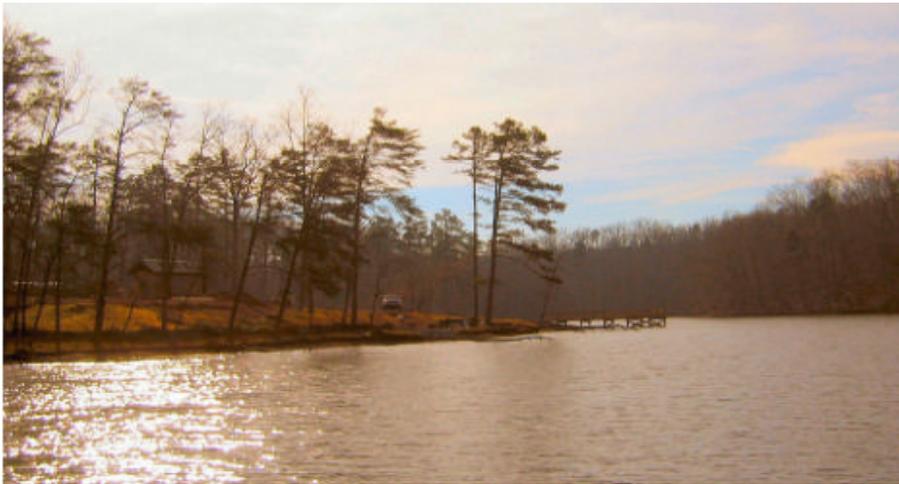
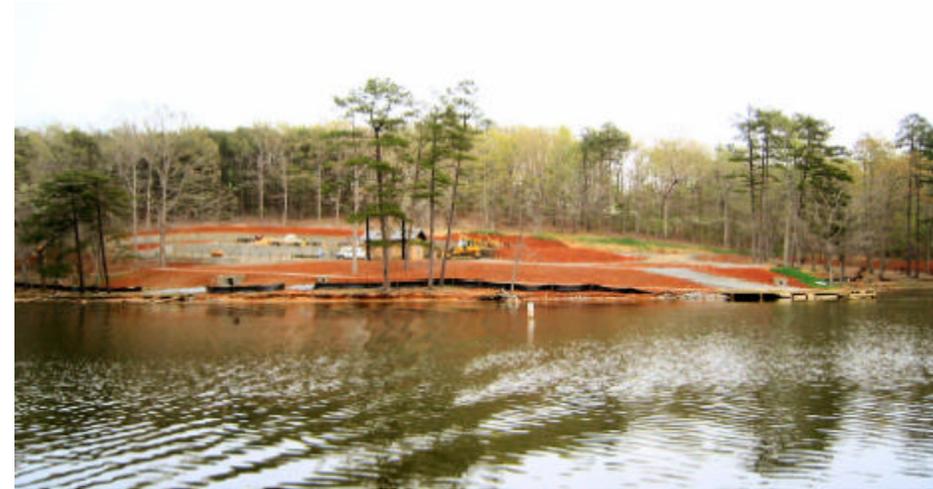
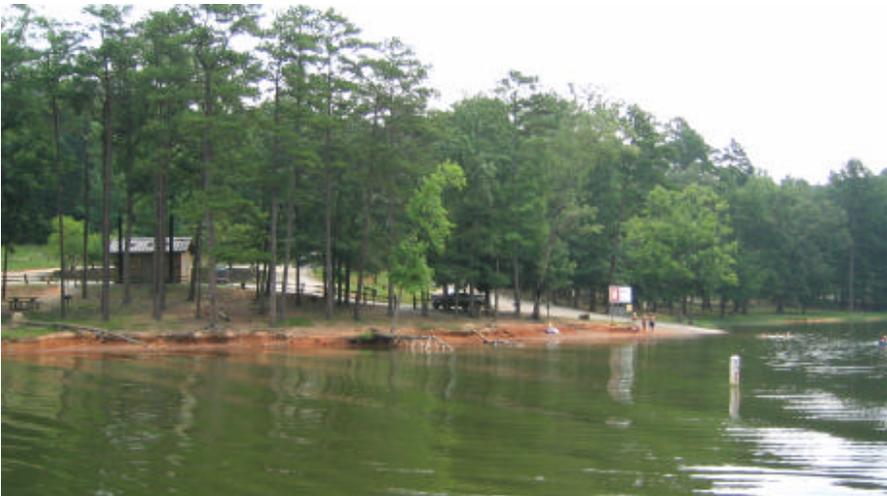
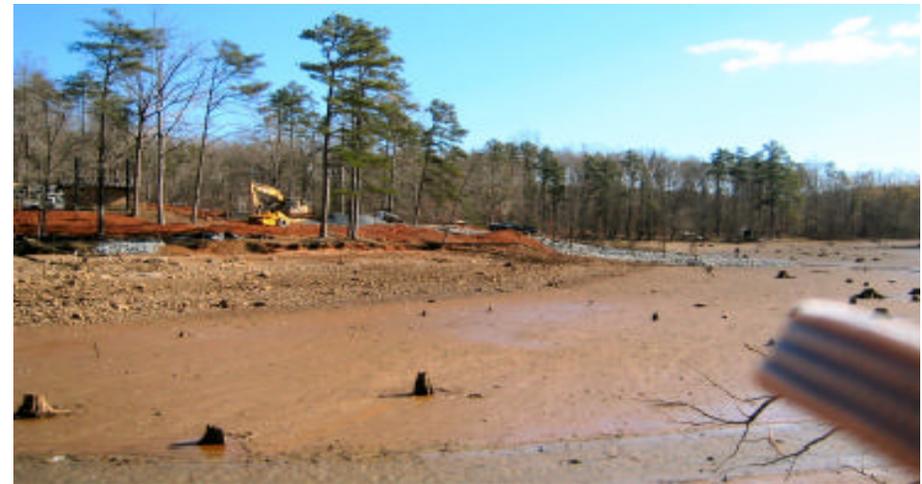
Narrows Reservoir
KOP NR 9: Cove Boat Landing

View Description									Modifier Rating		
KOP	Viewer Location	Project Feature	Setting	Primary Viewer Group	Number of Viewers	Duration of View	Distance Zone	Orientation	Field of View	Spatial Dominance	Scale Contrast	Compatibility
NR 9	Narrows reservoir offshore of Cove Boat Landing facing SSE.	Narrows Reservoir and Cove Boat Landing	View of Cove Boat landing from Narrows Reservoir	Boaters, anglers	Moderate	Short to long	Foreground	Direct	Wide	Subordinate	Minimal	Somewhat Compatible, December drawdown is not compatible

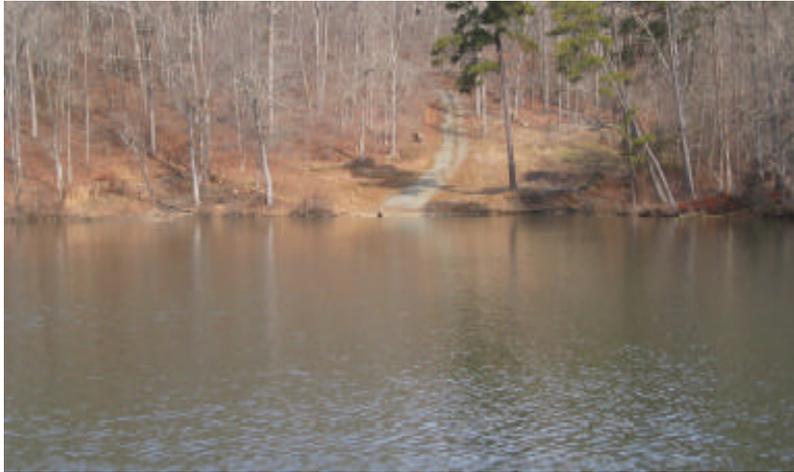
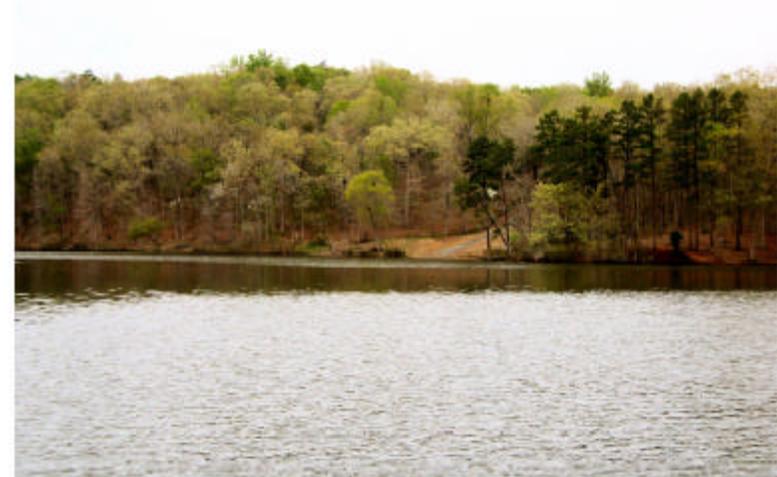
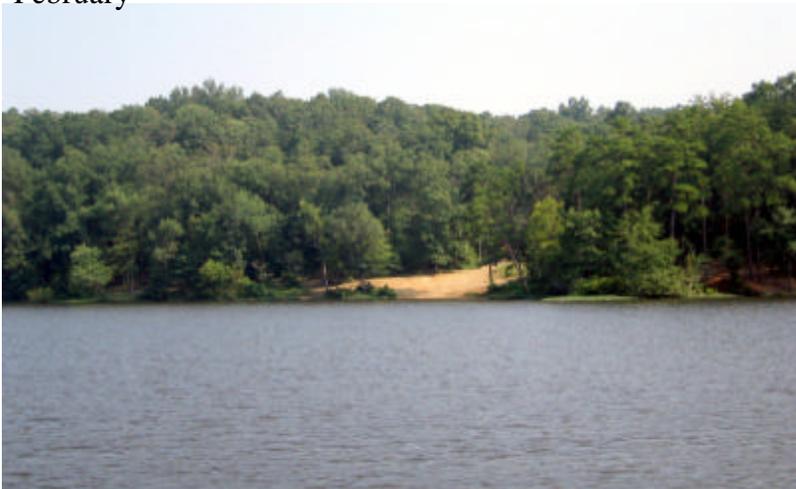
KOP FR 3: Uwharrie National Forest Deepwater Cove Trail from Water

The Deepwater Trail from this KOP appears disturbed and is somewhat compatible with the surroundings.

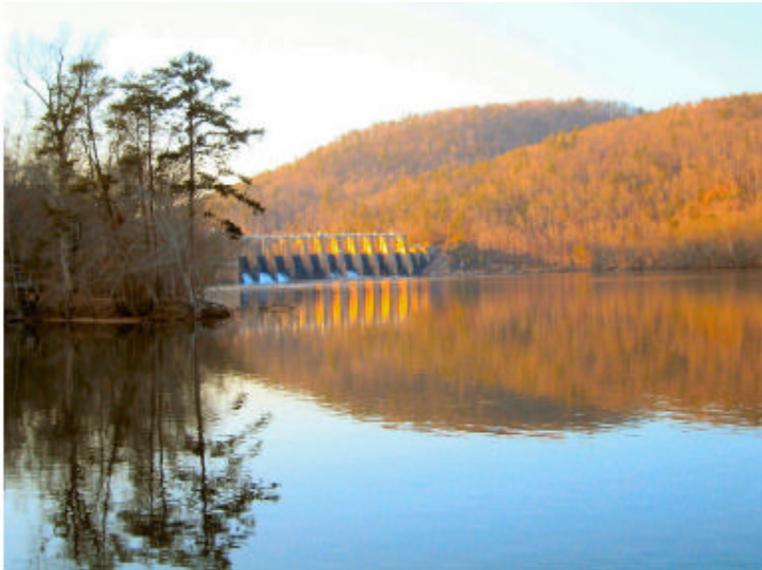
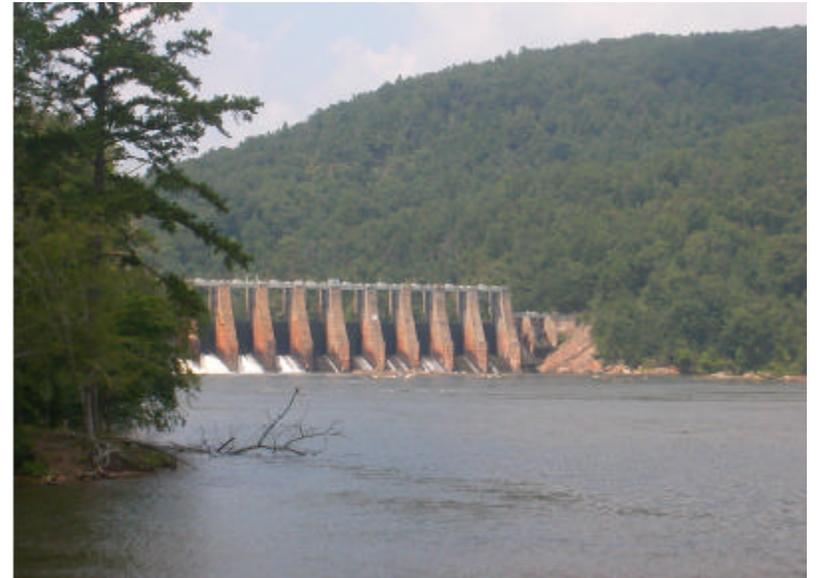
Falls Reservoir
KOP FR 4: Morrow Mountain State Park Trail

KOP	View Description									Modifier Rating		
	Viewer Location	Project Feature	Setting	Primary Viewer Groups	Number of Viewers	Duration of View	Distance zone	Orientation	Field of View	Spatial Dominance	Scale Contrast	Compatibility
FR 4	Morrow Mountain State Park Trail	Falls Dam and Tailrace	Wooded hillsides	Hikers, Anglers, Boaters	Moderate	Long	Foreground	Direct	Moderate	Co-dominant to subordinate	Minimal	Somewhat compatible
